**COMPANIA NAȚIONALĂ DE CĂI FERATE "C.F.R." S.A.**  
ROMANIAN RAILWAY NATIONAL COMPANY

**PODURI BRIDGES**

**RELEVU PASAJ KM 65+621 UNDERCROSSING KM 65+621 SURVEY**

SF 207 002 33 PS01 01 00

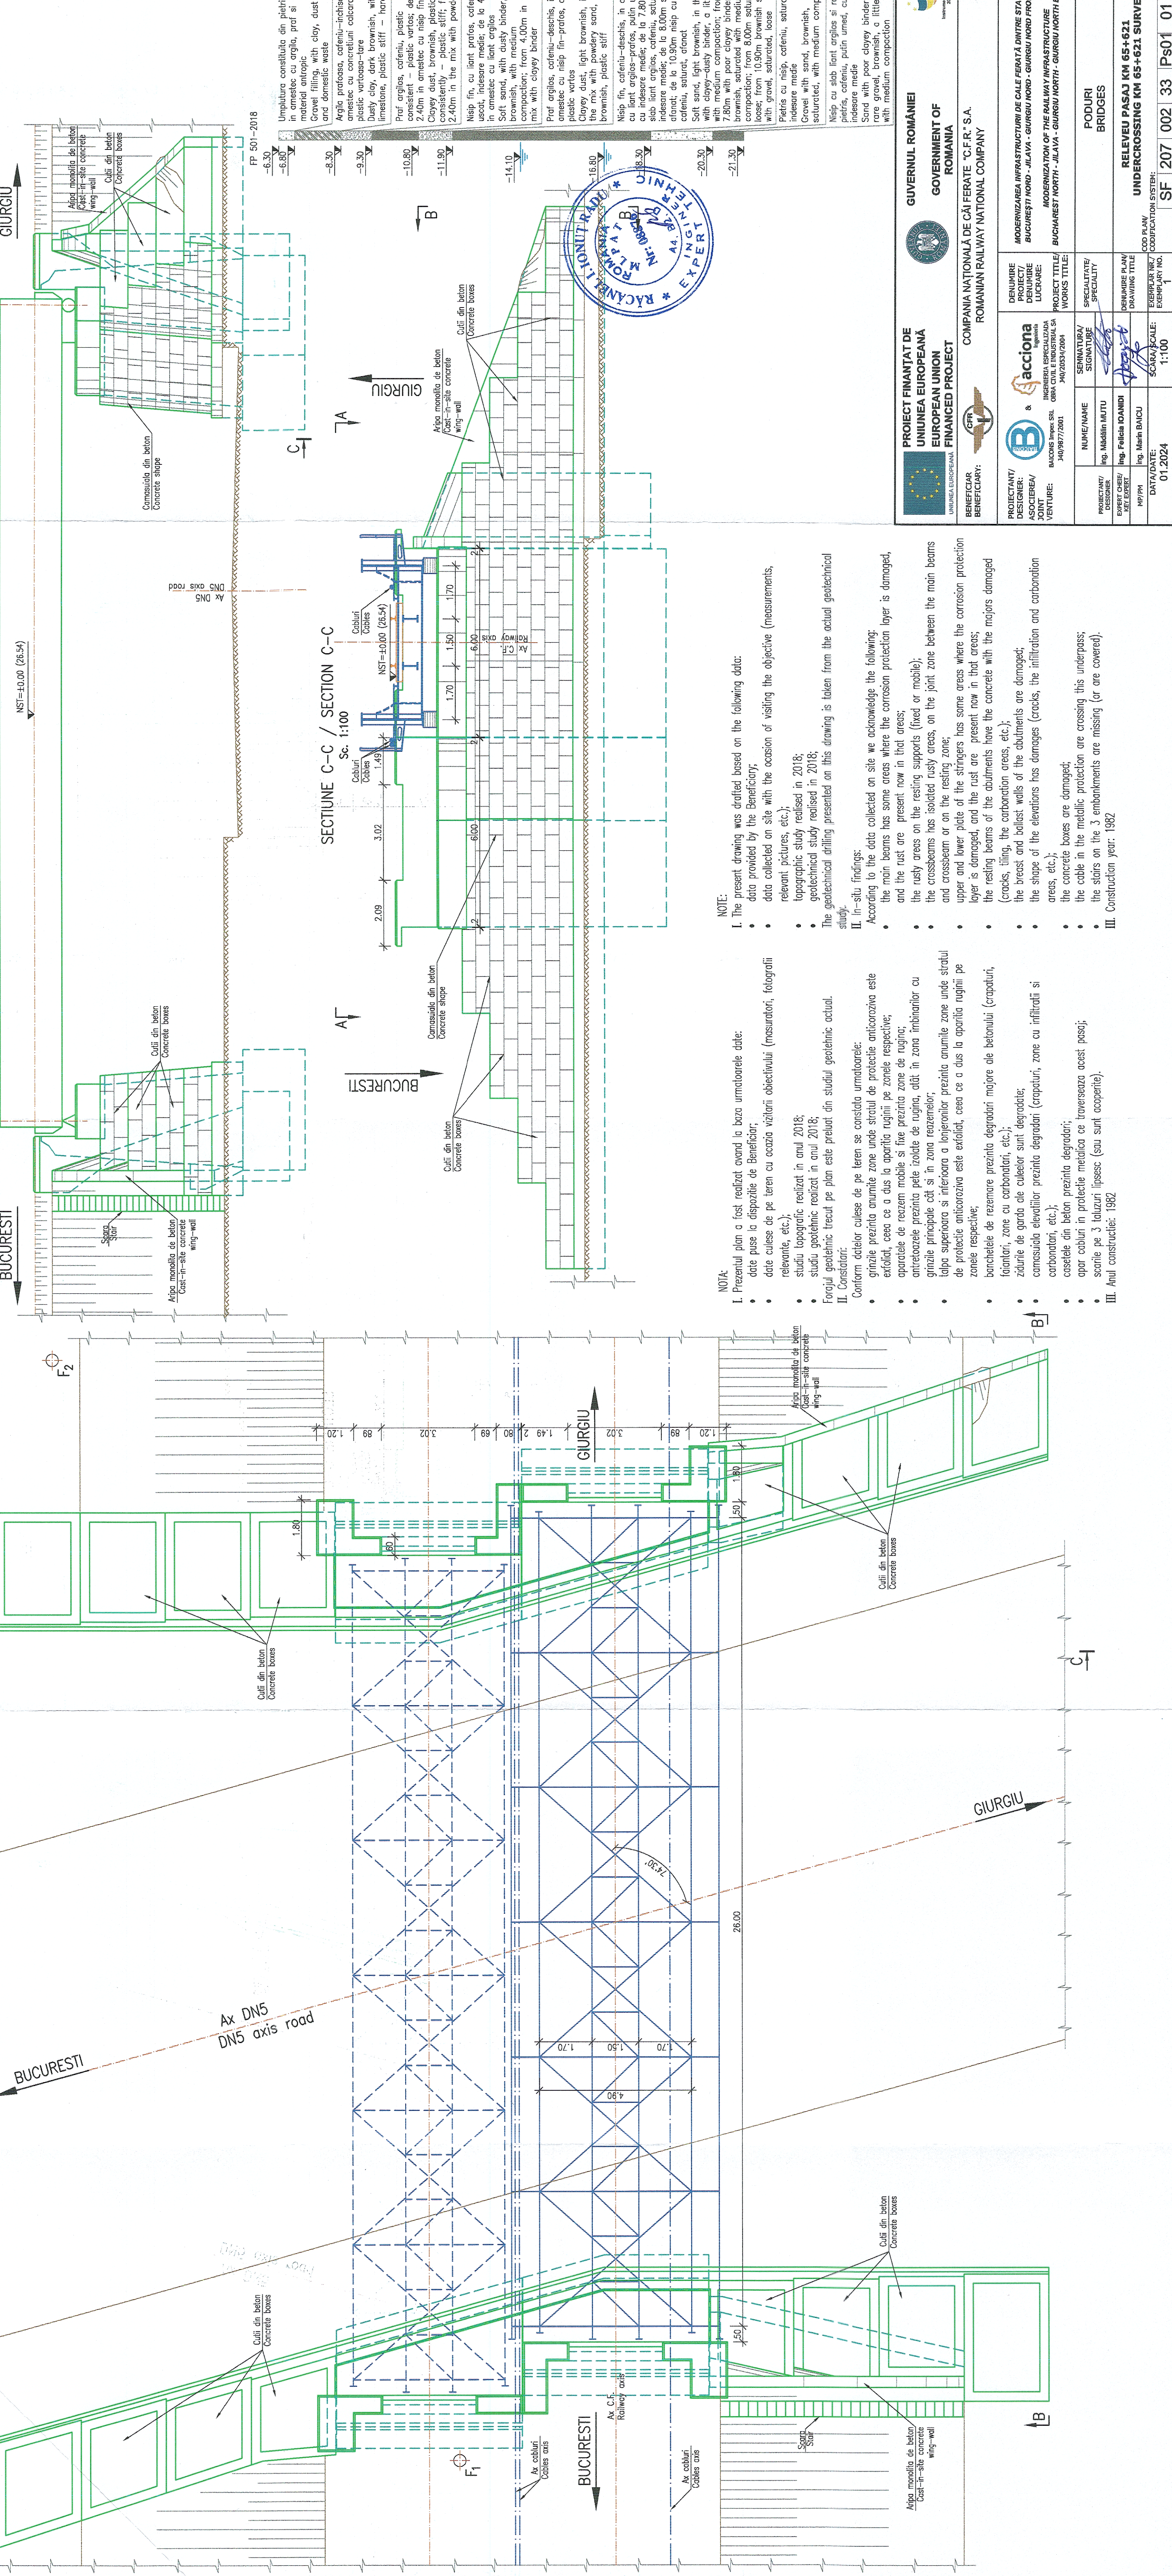
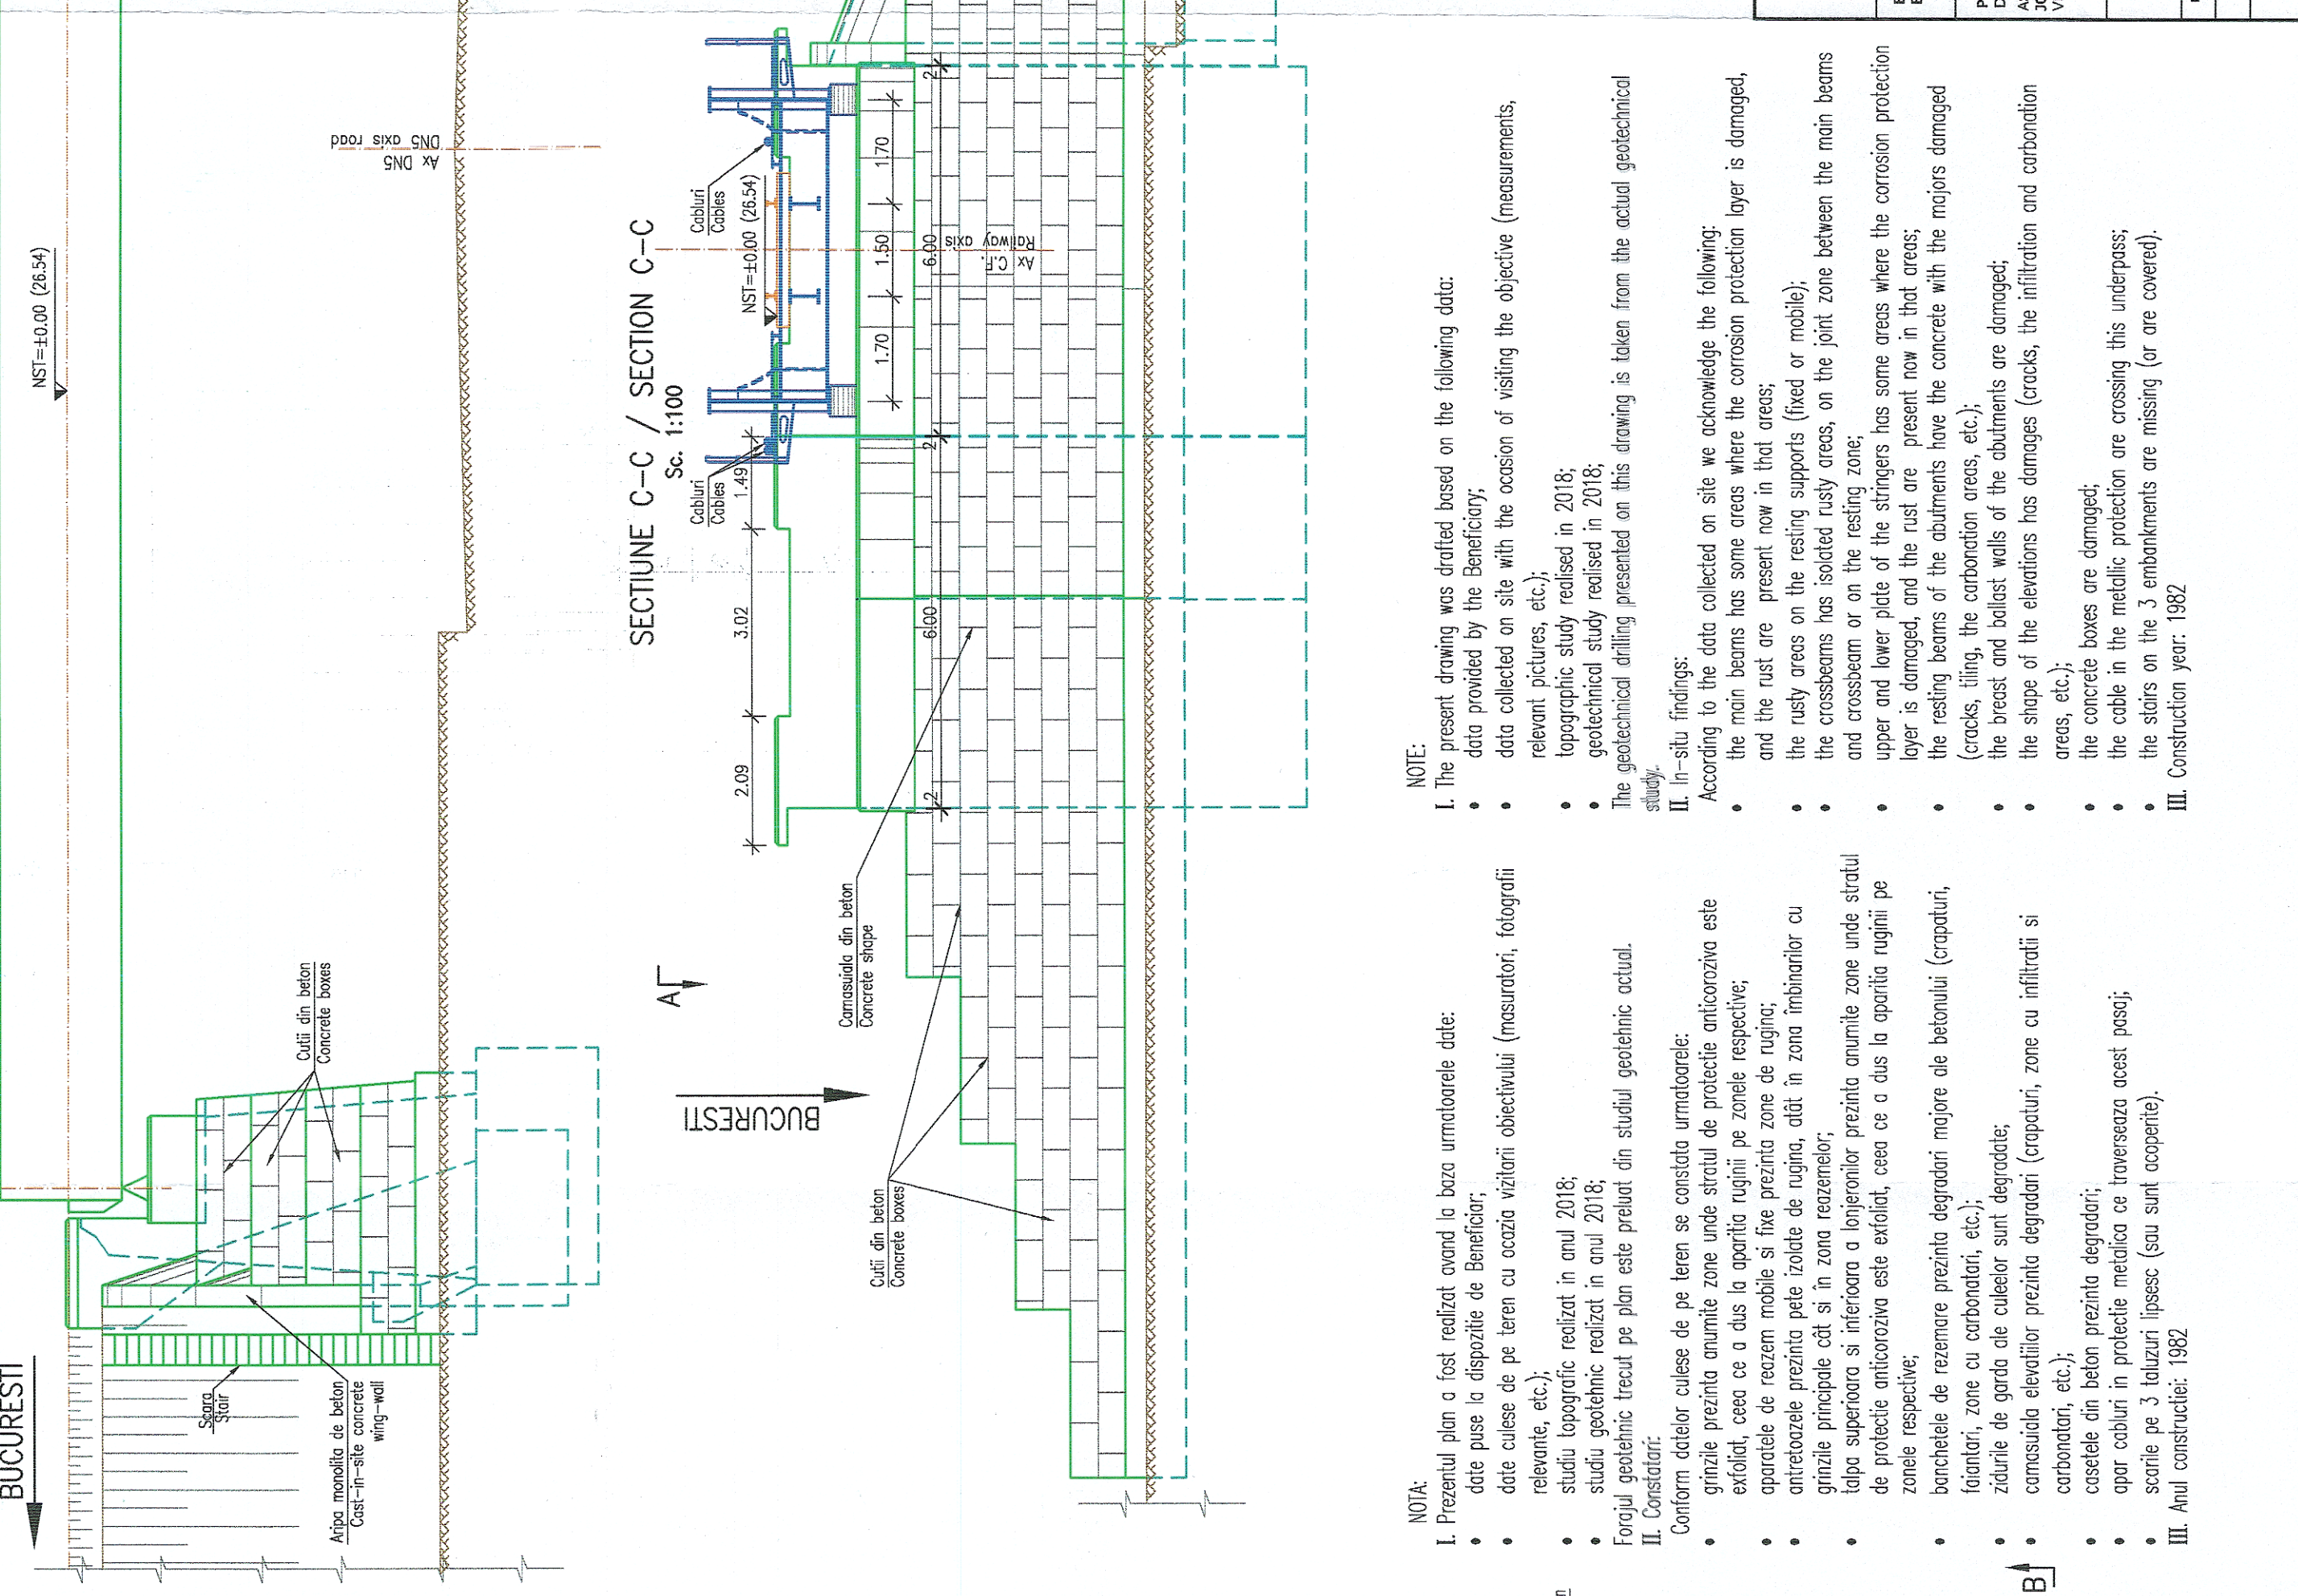
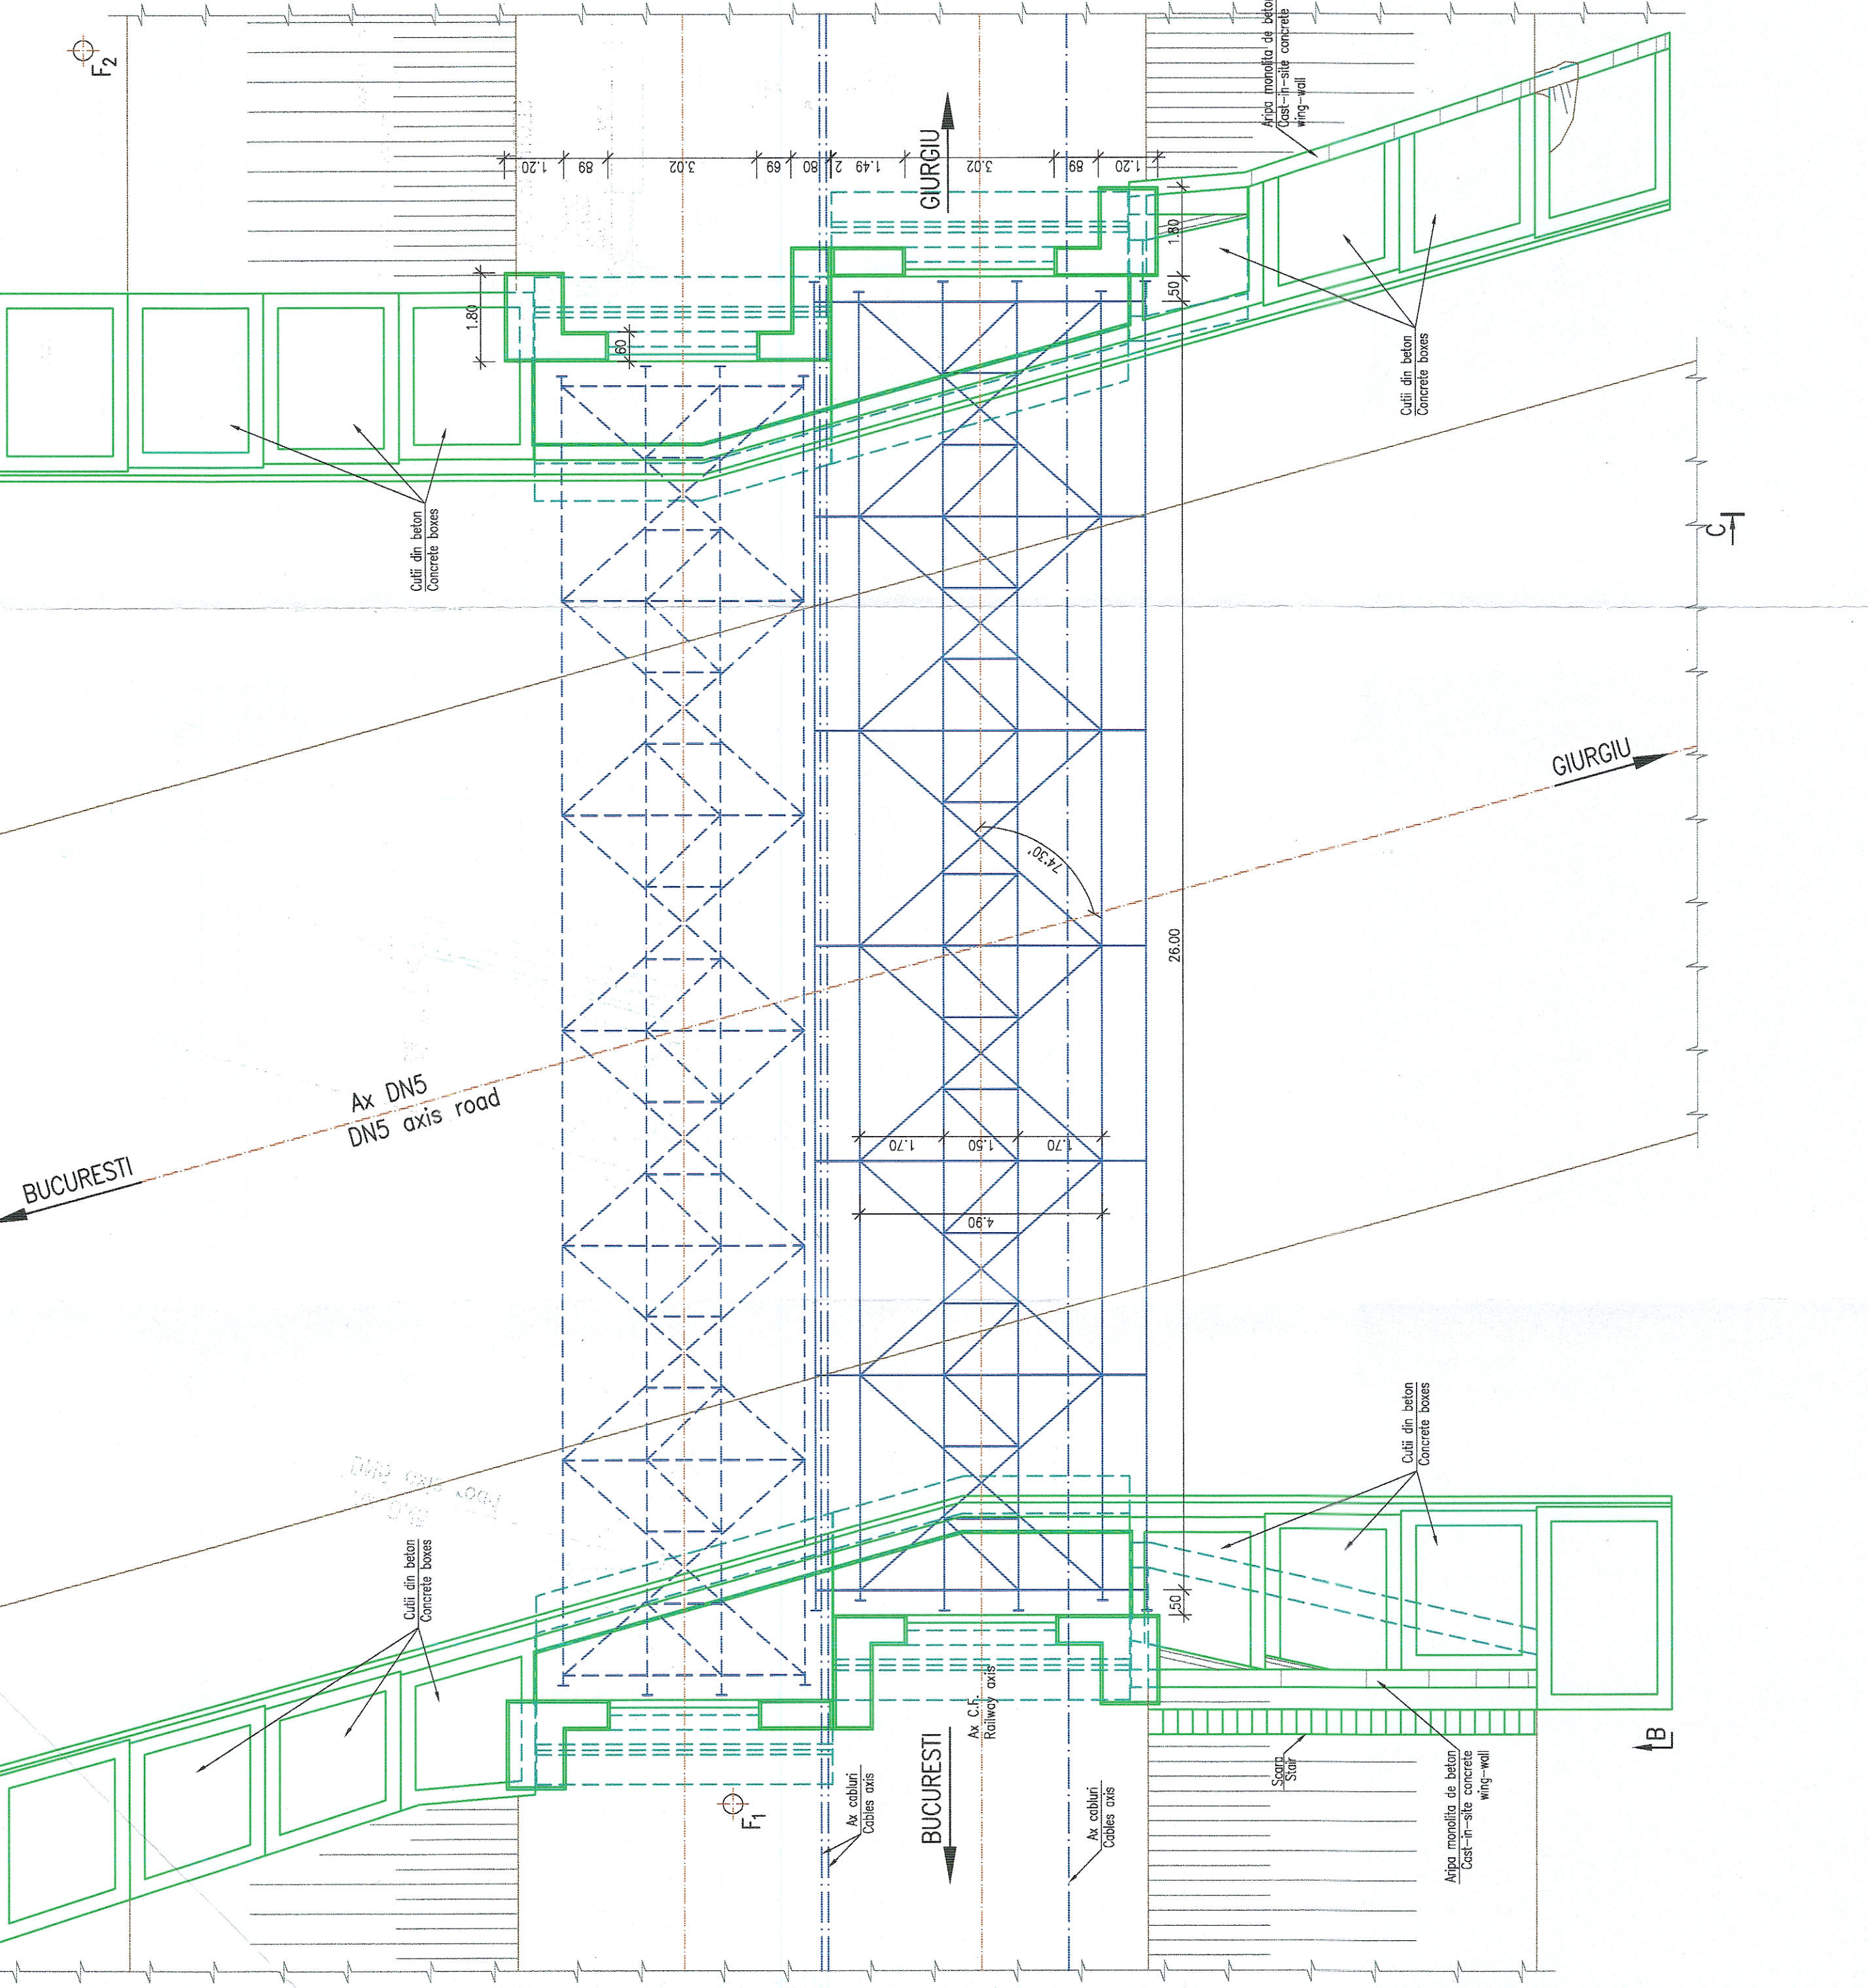
- According to the data collected on site we acknowledge the following:
  - the main beams has some areas where the corrosion protection layer is damaged, and the rust are present now in that areas;

- the rusty areas on the resting supports (fixed or mobile);
  - the crossbeams has isolated rusty areas, on the joint zone between the main beams and crossbeam or on the resting zone;

- upper and lower plate of the stringers has some areas where the corrosion protection layer is damaged, and the rust are present now in that areas;
  - the resting beams of the abutments have the concrete with the majors damaged (cracks, tilting, the carbonation areas, etc.);

- the breast and ballast walls of the abutments are damaged;
  - the shape of the elevations has damages (cracks, the infiltration and carbonation areas, etc.);

- the concrete boxes are damaged;
  - the cable in the metallic protection are crossing this underpass;
  - the stairs on the 3 embankments are missing (or are covered).
