PROJECT TITLE/ WORKS TITLE: "MODERNIZATION OF THE RAILWAY BUCHAREST NORTH - JILAVA - GIURGIU NORTH - GIURGIU NORTH BORDER"

SPECIALITATE/ SPECIALITY: PODURI BRIDGES

DENUMIRE PLAN/ DRAWING TITLE: RELEVU PODET KM 54+710

COD PLAN/ CODIFICATION SYSTEM: ET 207 Lot 2 28 Pd01 01 00

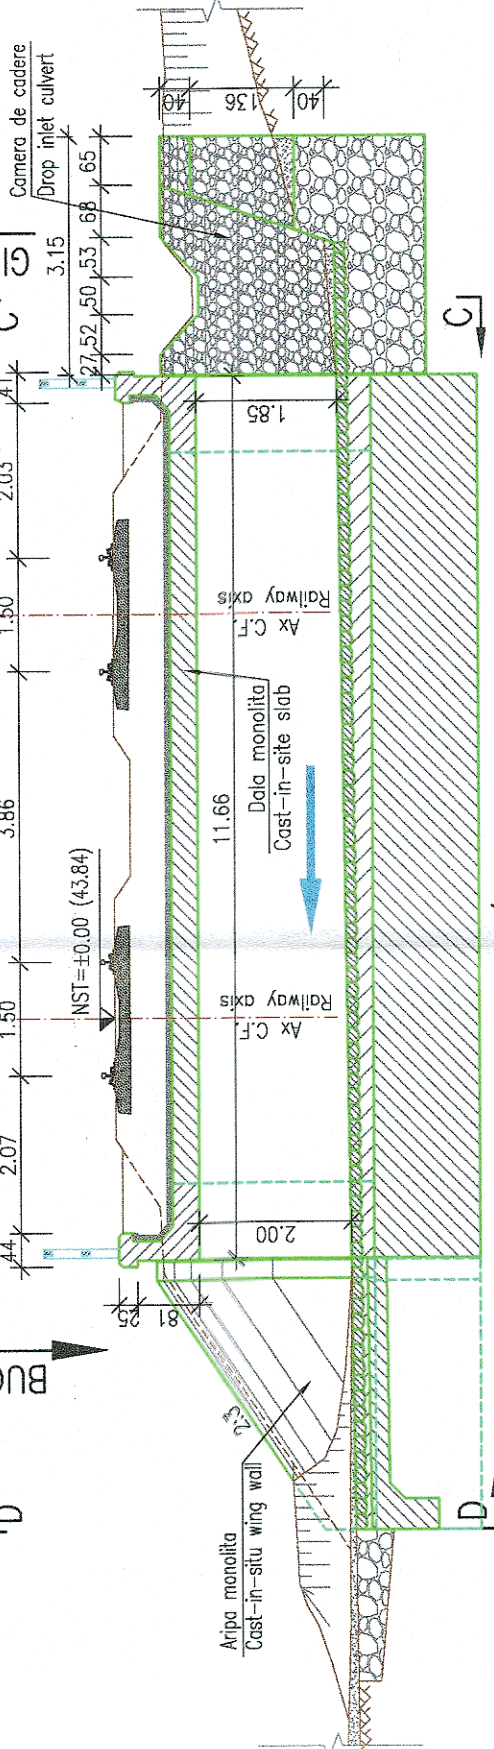
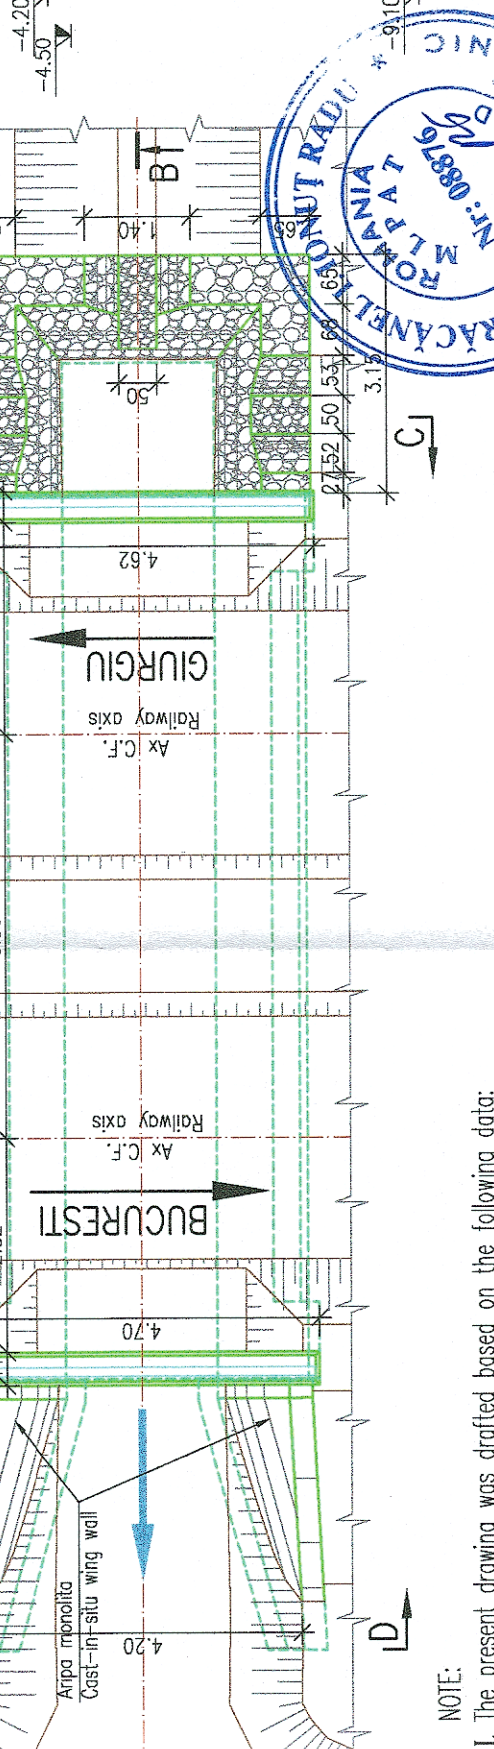
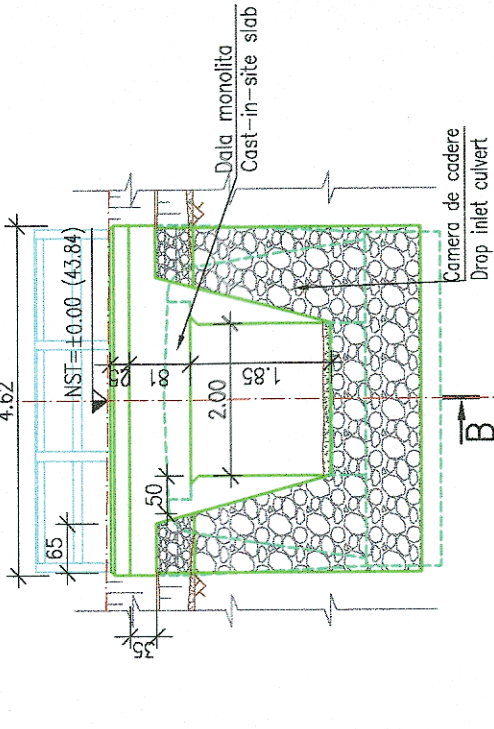
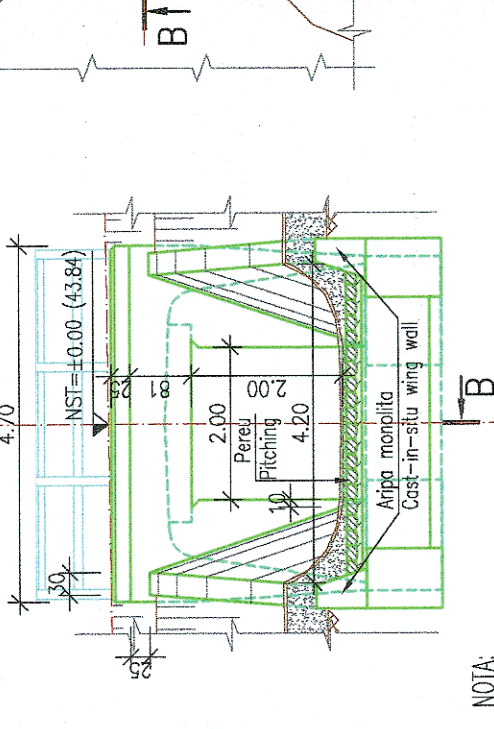
- ciobituri ale muchiilor, crapături, porțiuni cu segregări ale betonului;
- zone de carbonatari ca urmare a infiltrației apei la cele doua culei.
- pete de rugina, crapături, porțiuni cu segregări ale betonului la intradosul dalei;
- parapetii de protecție sunt ușor degradați;
- degradarea usoara a aripilor monolite din aval;
- camera de cadere, realizata din zidarie de piatra, prezinta degradari (mortarul de legatura desprins în unele zone, pietre desprinse, etc.)
- nu se observa scările pe taluzuri;
- albia prezinta o usoara colmatare în amonte si aval, iar sub podet pereul este la vedere.

- cracks of the edges, cracks, concrete segregated areas, the carbonation areas at the abutments as a result of water infiltration.
- the rusty areas, cracks, concrete segregated areas at the soffit of the deck;
- the pedestrian guardrail are easy damaged;
- the cast-in-situ wing-walls easy damaged, which are downstream by the culvert;
- the drop inlet culvert, made by stones masonry, have the linking mortar missing in some areas, the detached stones, etc.
- the stairs on the both side of the backfill are missing;
- upstream and downstream the river bed have a soft mudding, and over the culvert the pitching it's out of sight.
