<p>PROIECT FINANȚAT DE UNIUNEA EUROPEANĂ EUROPEAN UNION FINANCED PROJECT</p>		<p>BENEFICIAR: COMPANIA NAȚIONALĂ DE CĂI FERATE "C.F.R." S.A. ROMANIAN RAILWAY NATIONAL COMPANY</p>		<p>GUVERNUL ROMÂNIEI GOVERNMENT OF ROMANIA</p>	
<p>PROIECTANT/ DESIGNER: ACCIONA ASOCIEREA/ JOINT VENTURE: 140/20534/2004</p>		<p>DENUMIRE PROIECT/ DENUMIRE LUCRARE: "MODERNIZAREA INFRASTRUCTURII DE CALE FERATE DINTRE STATILE CF BUCURESTI NORD - GIURGIU NORD - JILAVA - GIURGIU NORD FRONTIERA" PROJECT TITLE/ WORKS TITLE: "MODERNIZATION OF THE RAILWAY BUCHAREST NORTH - JILAVA - GIURGIU NORTH - GIURGIU NORTH BORDER"</p>		<p>"MODERNIZAREA LINIEI CF BUCURESTI NORD-JILAVA-GIURGIU NORD-GIURGIU NORD FRONTIERA" Lot 2 - MODERNIZAREA INFRASTRUCTURII DE CALE FERATE DINTRE STATILE CF BUCURESTI NORD - GIURGIU NORD - JILAVA - GIURGIU NORD FRONTIERA Lot 2 - MODERNIZATION OF THE RAILWAY BUCHAREST NORTH - GIURGIU NORTH - GIURGIU NORTH BORDER</p>

<p>NUME/NOME: Ing. Madalin Mutu</p>		<p>SPECIALITATE/ SPECIALITY: PODURI BRIDGES</p>		<p>RELEVU PODET KM 64+951 CULVERT SURVEY KM 64+951</p>	
<p>SEMANTURA/ SIGNATURE: [Signature]</p>		<p>COD PLAN/ CODIFICATION SYSTEM: ET 207 Lot 2 33 Pd01 01 00</p>		<p>EXEMPLAR NR./ EXEMPLARY NO. 1

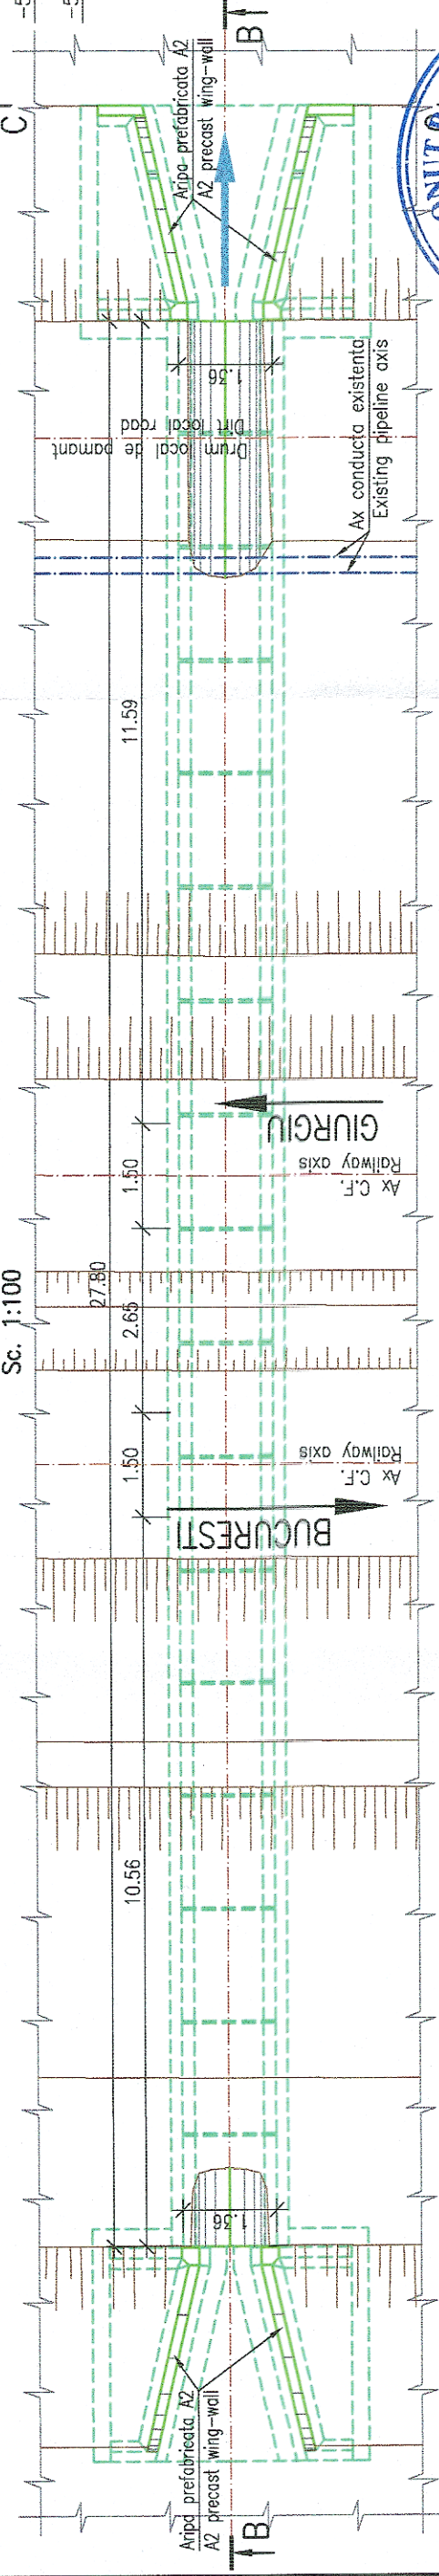
VEDERE PLANA A-A / A-A PLAN VIEW

- II. Constatari:
 - Conform datelor culesse de pe teren se constata urmatoarele:
 - degradarea betonului cadrelor de beton armat prefabricat C1 (crapaturi, zone cu usoare pete de rugina si de carbonatare ca urmare a infiltratiei apei, zone mari acoperite cu funingine etc);

- degradarea materialului de umplere a rosturilor dintre cadrele prefabricate;
 - parapetii de protectie lipsesc;
 - degradarea aripilor prefabricate (armatura la vederea, ciobituri ale muchiilor, crapaturi, etc.);

- scariile pe taluzuri lipsesc sau sunt acoperite, lipsesc parapetele de siguranta;
 - albia prezinta o colmatare medie in amonte si aval, si vegetatie inalta.

- II. In-situ findings:
 - According to the data collected on site we acknowledge the following:
 - the C1 frames concrete damaged (the cracked, the rusty and carbonation areas as a result of water infiltration, the large areas covered by smoke, etc);

- the mortar damaged at the filling area between C1 precast frames;
 - the pedestrian guardrail are missing;
 - the precast wing-walls damaged (the expose reinforcement, cracks of the edges, cracks, etc.);

- the stairs on the embankments are missing or are covered, the safety handrails are missing;
 - upstream and downstream the river bed have a medium mudding area, and a tall vegetation.
