<b>PROIECTANT/ DESIGNER:</b> EXPERT CHEIE/ KEY EXPERT M/PM		<b>SPECIALTATE/ SPECIALITY:</b> PODURI BRIDGES	
<b>DATA/DATE:</b> 04.2018		<b>DENUMIRE PLAN/ DRAWING TITLE:</b> RELEVU PODET KM 65+816 CULTVERT SURVEY KM 65+816	
<b>SCALA/SCALE:</b> 1:100		<b>EXEMPLAR NR./ EXEMPLARY NO.:</b> 1	
<b>COD PLAN/ CODIFICATION SYSTEM:</b>		<b>ET 207 Lot 2 33 Pd02 01 00</b>

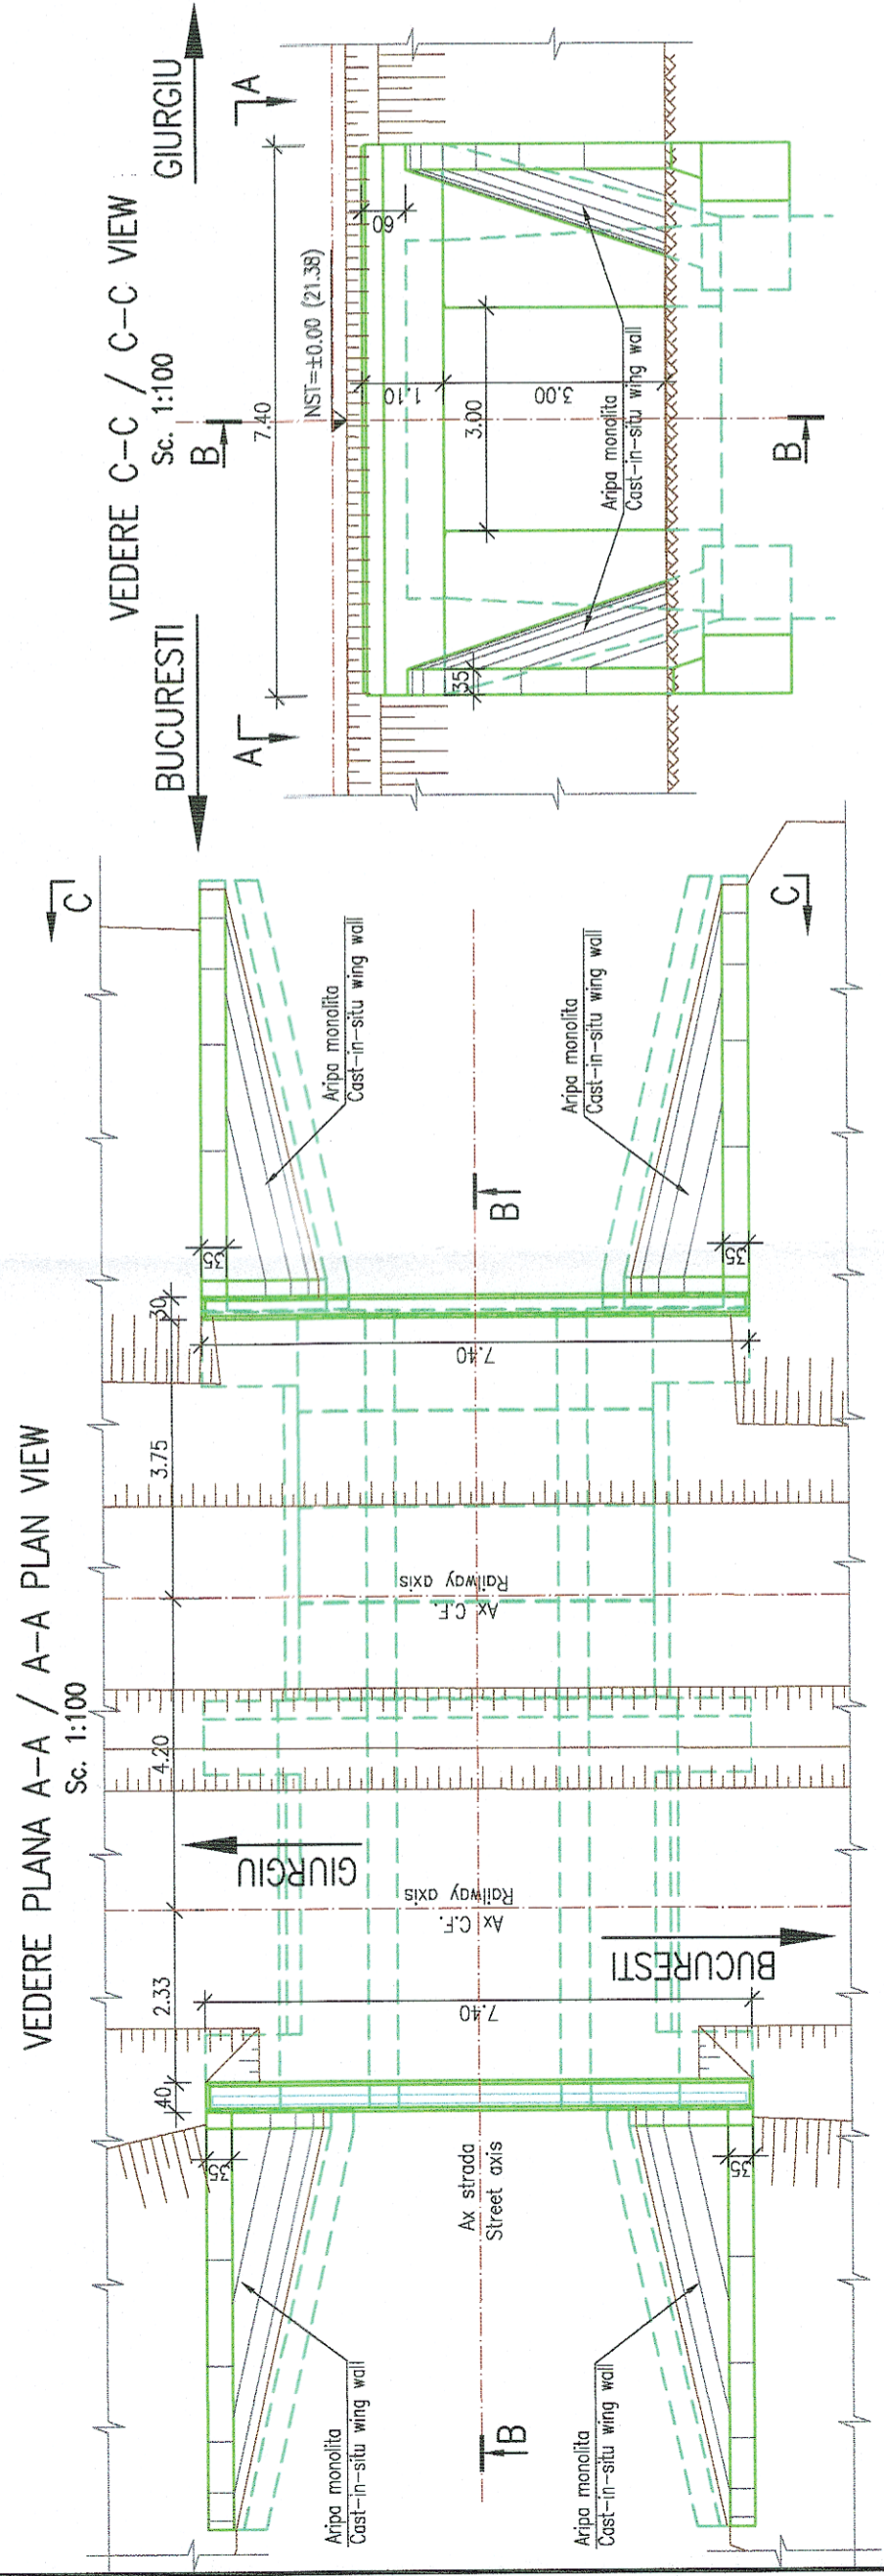
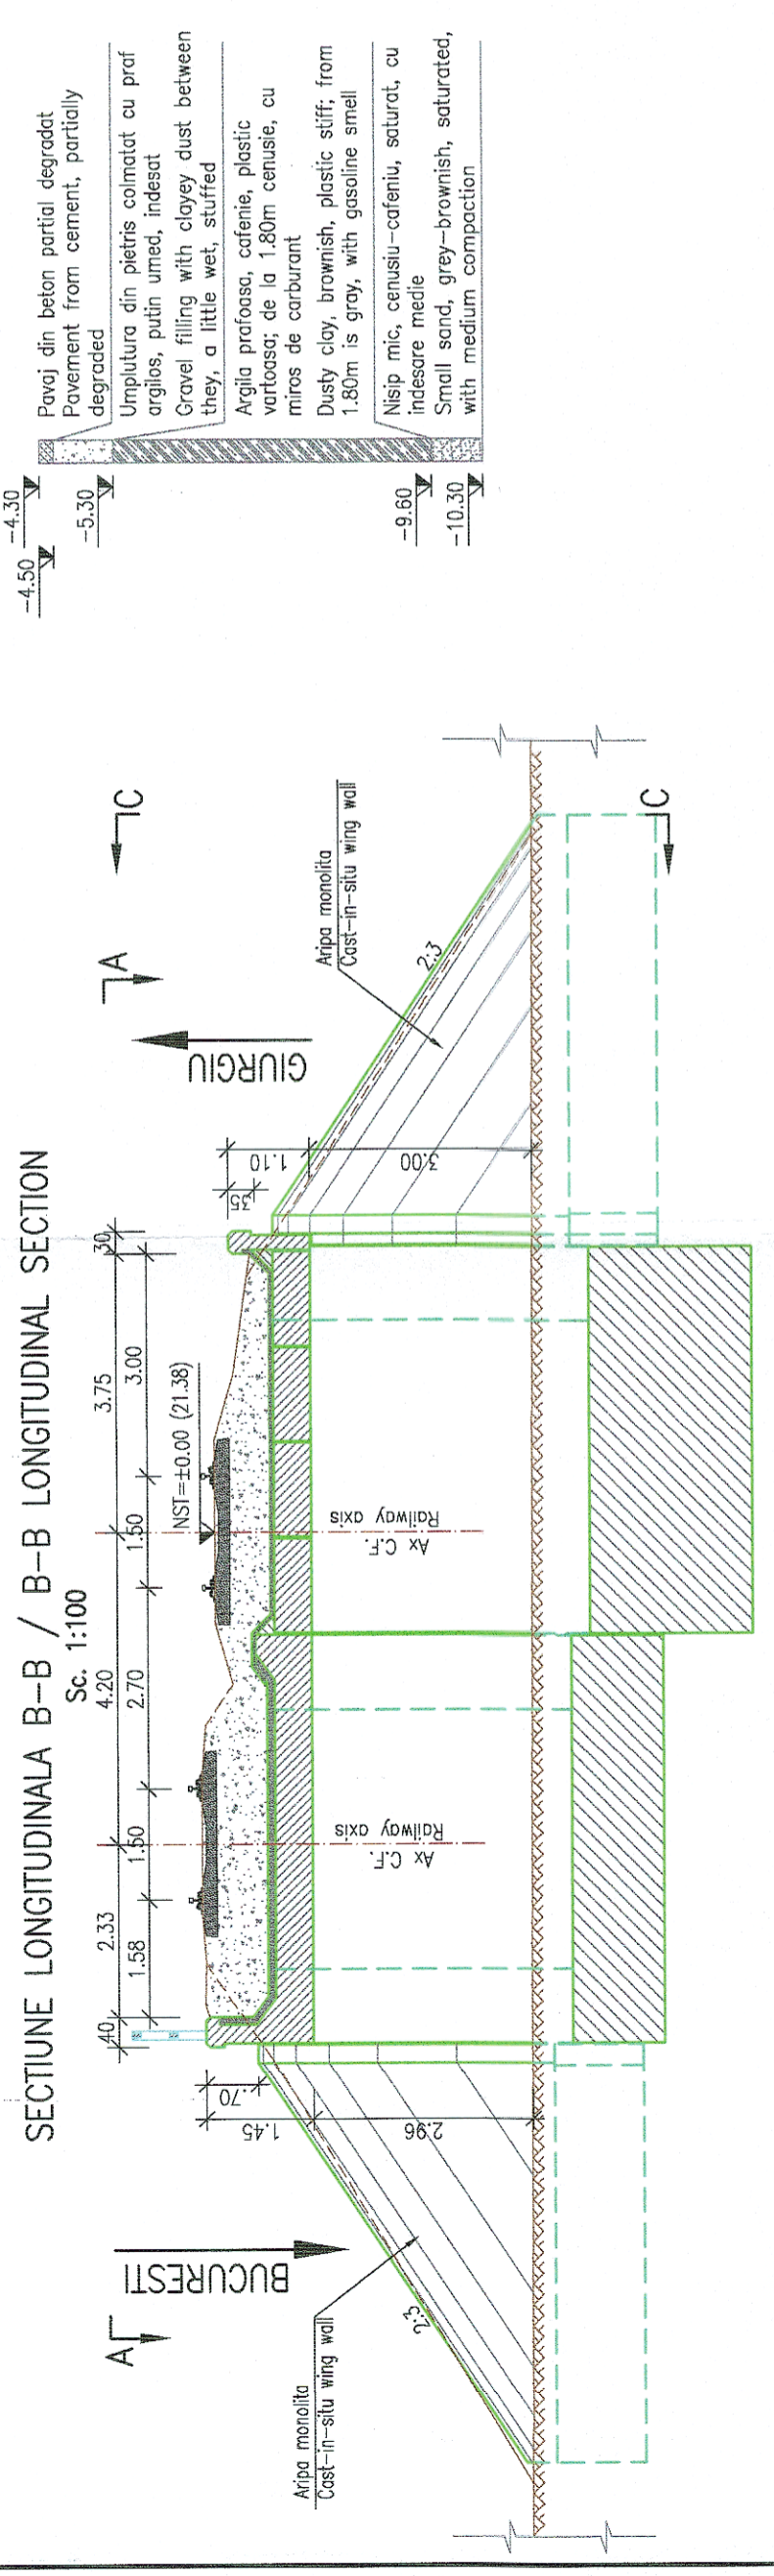
- Conform datelor culesse de pe teren se constata urmatoarele:
  - ciobituri ale muchiilor, crapaturi, zone cu segregari ale betonului, zone de carbonatari ca urmare a infiltratiei apei la cele doua culci;
  - zone cu crapaturi, zone de carbonatari ca urmare a infiltratiei apei la intradosul dalelor, zone cu armaturi descoperite si ruginite;
  - parapetele de protectie de pe partea dreapta lipseste;
  - degradarea aripilor monolite;
  - scările pe taluzuri lipsesc sau sunt acoperite, lipsesc parapetele de siguranta;
  - strada pe care o supratraverseaza este degradata.
- III. Anii constructiei: 1966; 1979

- According to the data collected on site we acknowledge the following:
- cracks of the edges, cracks, concrete segregated areas, the carbonation areas as a result of water infiltration at the abutments;
  - cracks, the carbonation areas at the soffit of the deck as a result of water infiltration, the expose corroded reinforcement areas;
  - the pedestrian guardrail are missing on the right side;
  - the cast-in-situ wing-walls damaged;
  - the stairs on the embankments are missing or are covered, the safety handrails are missing;
  - the street (under the culvert) is damaged.
- III. Construction years: 1966; 1979
