DENUMIRE/ PROJECT/ DENUMIRE LUCRARE: "MODERNIZAREA LINIEI DE BUCUREȘTI NORD-JILAVA-GIURGIU NORD - GIURGIU NORD FRONTERA"
PROIECT/TITLE/ WORKS TITLE: "MODERNIZATION OF THE RAILWAY BUCUREȘTI NORTH - JILAVA - GIURGIU NORTH - GIURGIU NORTH BORDER" NORTH - GIURGIU NORTH - GIURGIU NORTH BORDER
SPECIALITATE/ SPECIALITY: PODURI BRIDGES

EXEMPLAR NR./ EXEMPLARY NO.: 1
COD PLAN/ CODIFICATION SYSTEM: RELEVU PODET KM 30 +928
CULVERT SURVEY KM 30+928

ET 207 Lot2 19 Pd05 01 00

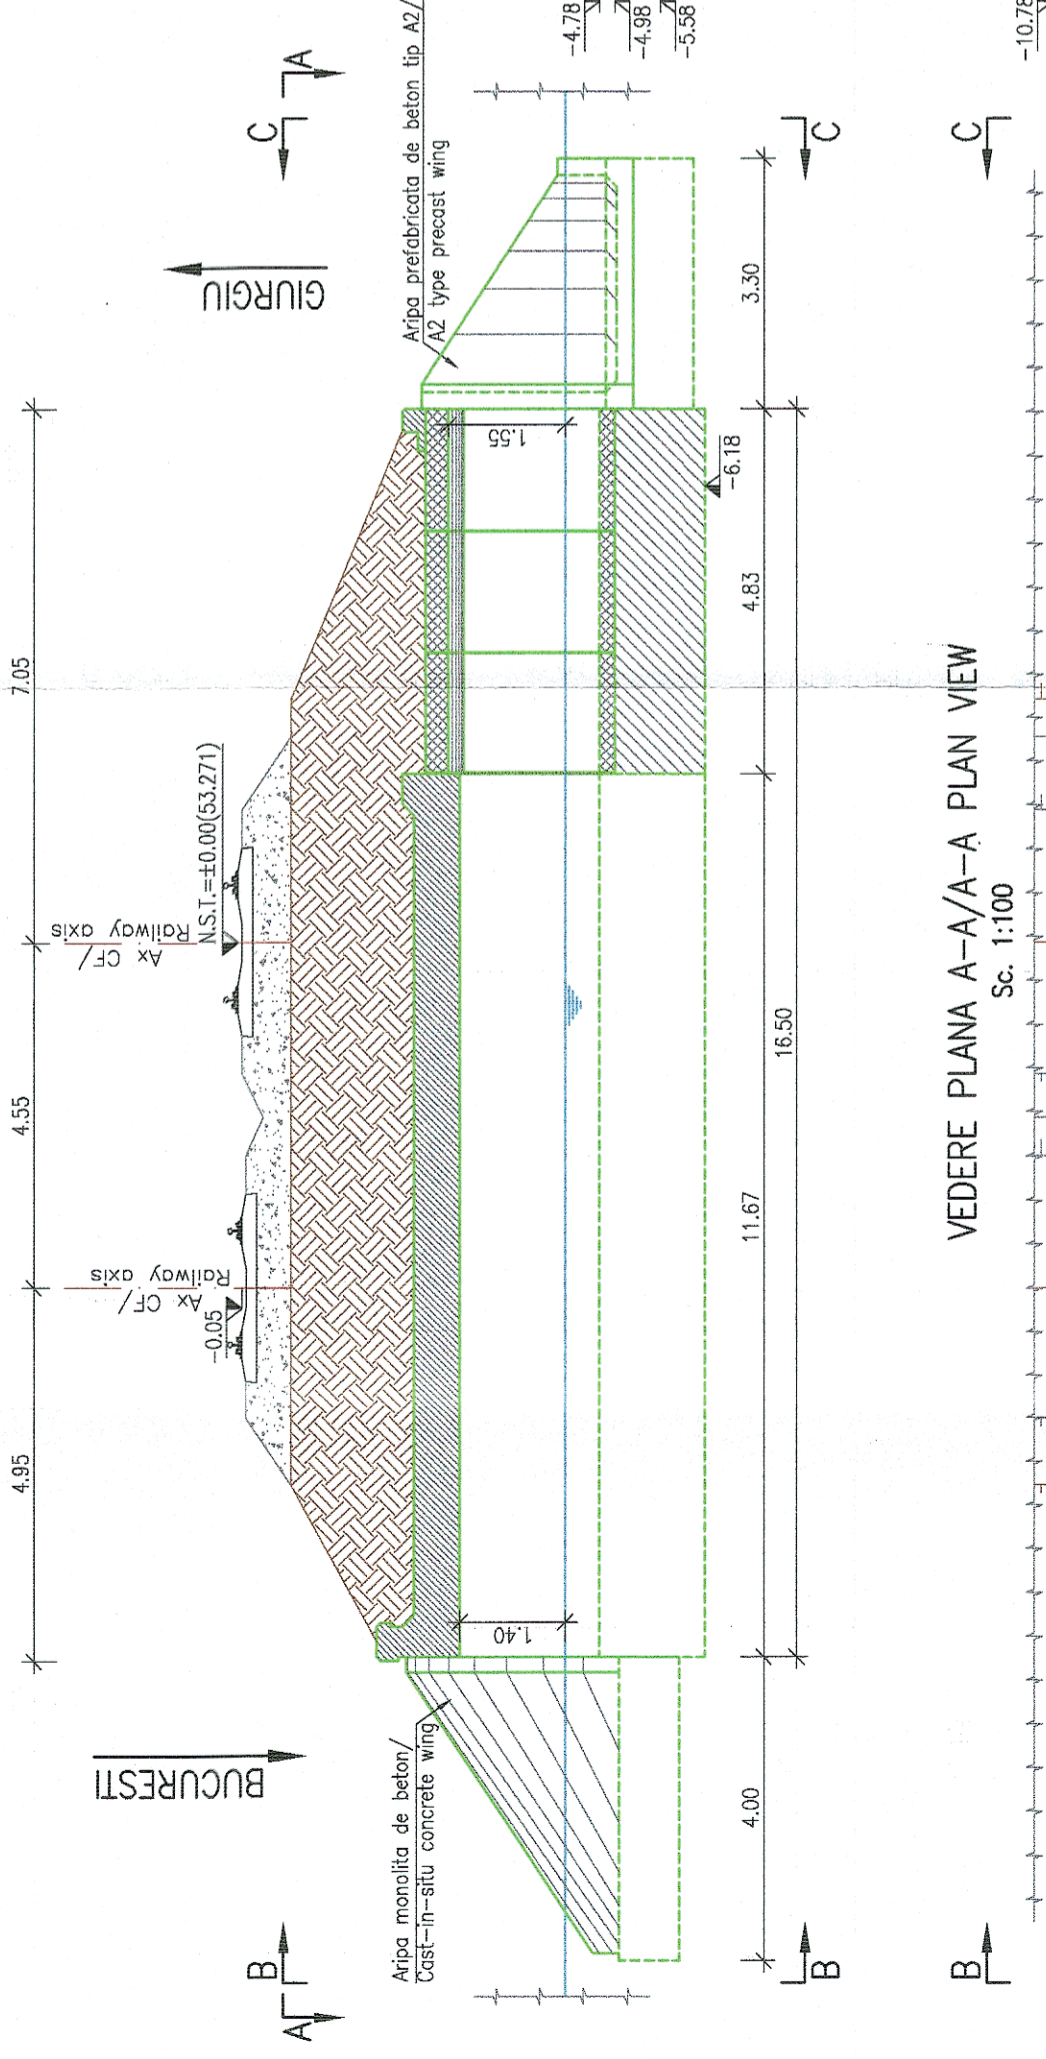
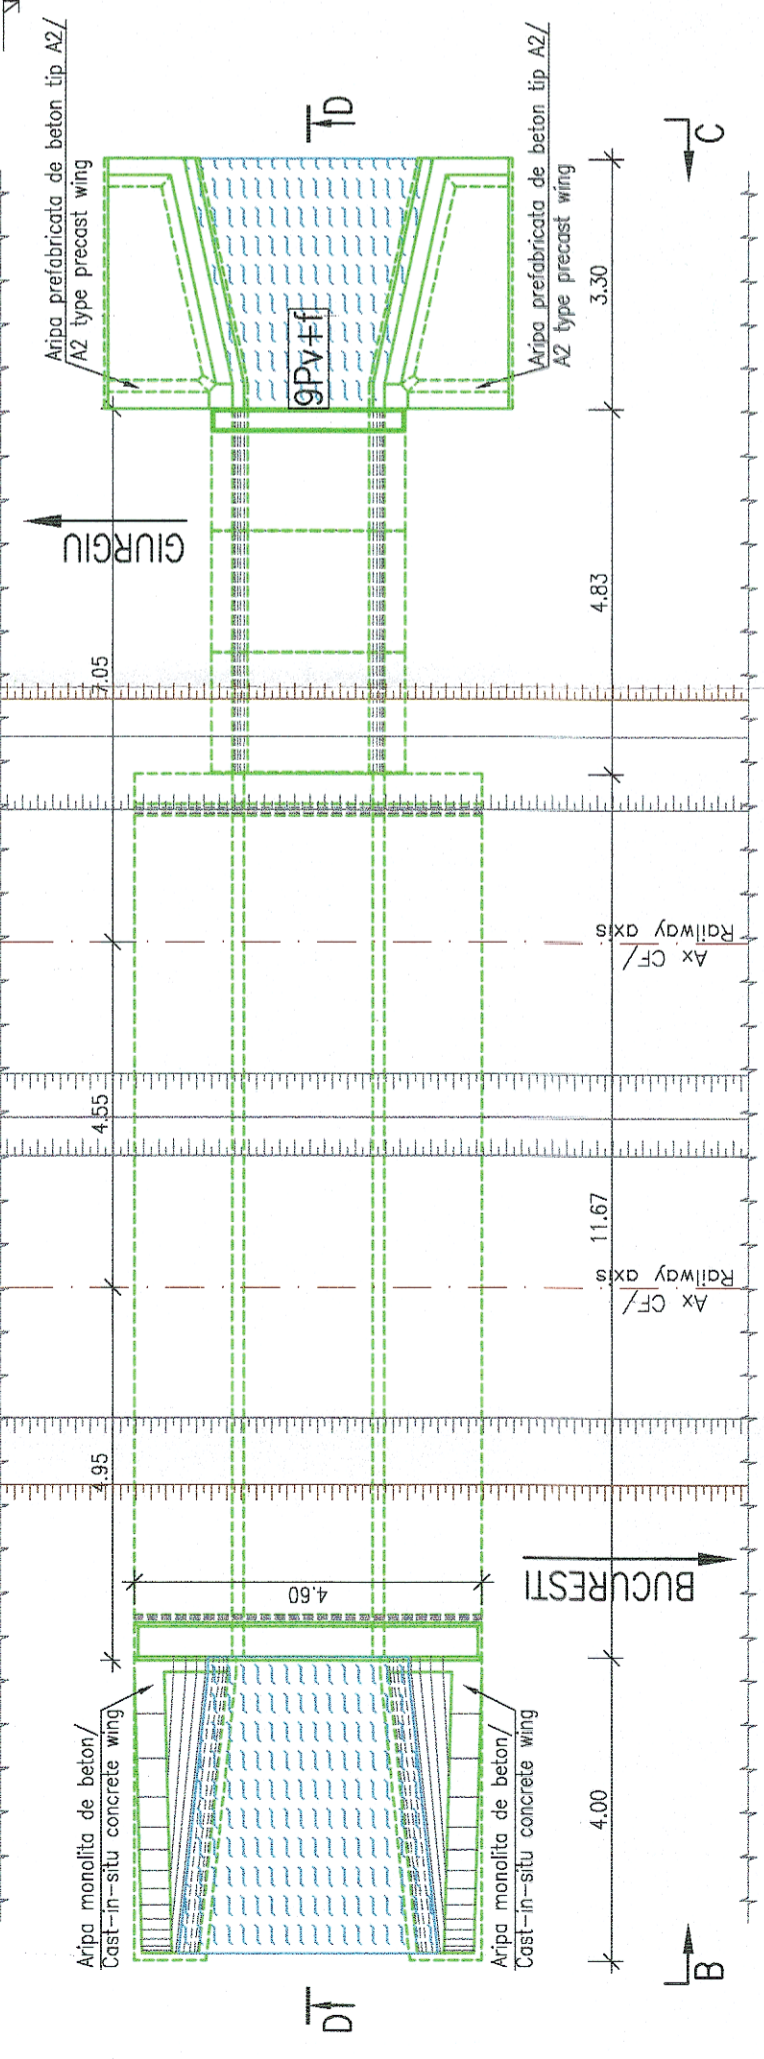
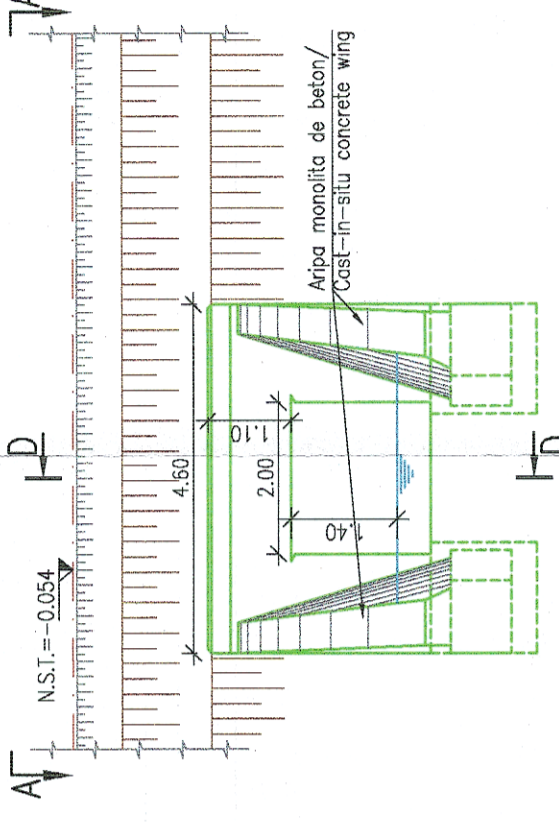
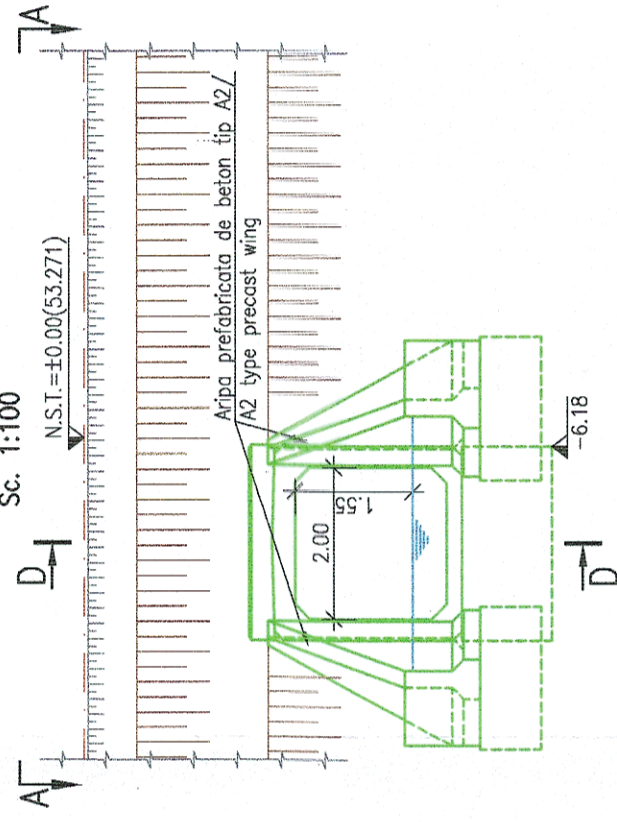
- II. Constatări:
 - Conform datelor culese de pe teren se constată următoarele:
 - podetul este inundat;
 - prezenta la interiorul coarelor, la intrados a unor zone cu beton degradat și armatura dezvelită corodată;

- infiltrații ale apei la interiorul cadrelor prefabricate;
 - degradări ale betonului elevațiilor podetului dalat;
 - lipsa parapetelor pe timpone.
- According to the data collected on site we acknowledge the following:

- the culvert is flooded;
 - the precast wing concrete is degraded;
 - partial areas of degraded concrete and unweiled and corroded rebars at the soffit and the interior part of the precast frames;

- water infiltration at the interior of the precast frames;
 - degraded concrete at the elevations of the concrete slab culvert;
 - the absence of the handrails on both tympanns.
