**STATIA C.F. PASAREA / PASAREA RAILWAY STATION
CLADIRE DE CALATORI / PASSENGER BUILDING**

**Lucrari de reparatii - Plan consolidare pereti etaj 1 /
Repair works - 1st floor wall consolidation plan**

**Lucrari de reparatii - Plan consolidare pereti parter /
Repair works - ground floor wall consolidation plan**

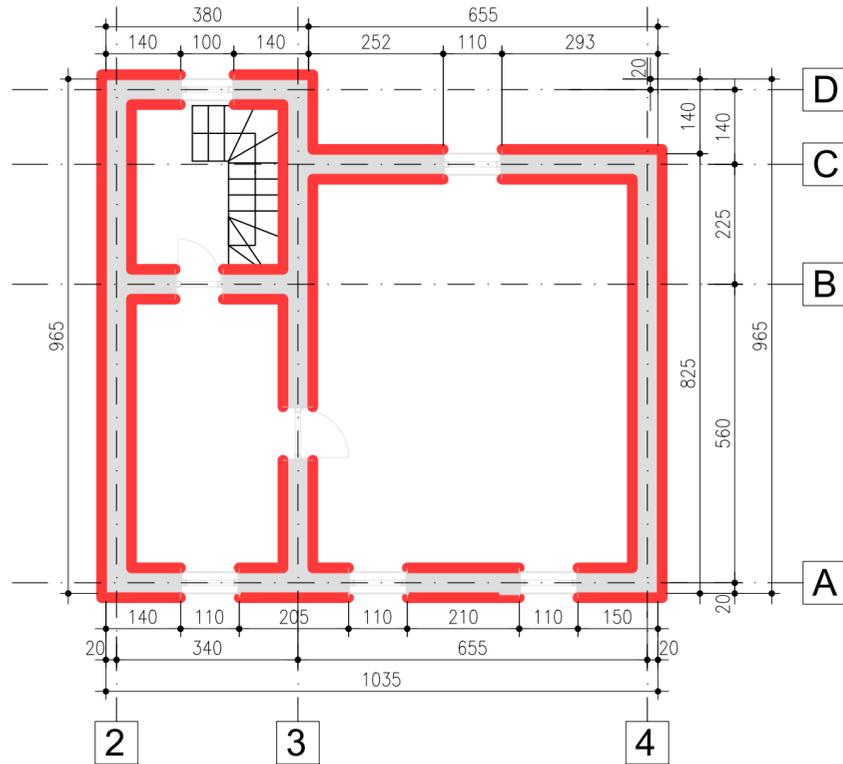
- Tinand cont ca constructiile se afla in zona seismica cu $a_g=0.30g$ si coreland acesta cu cerintele normativului P100/1-2013 in care se specifica numarul maxim de niveluri acceptate pentru constructiile de tip ZNA, tinad cont de degradarile observate in peretii de zidarie, pentru imbunatatirea conditiilor de siguranta structurala propunem consolidarea peretilor de zidarie cu camasiuala armata minim 8cm grosime pe ambele parti si plasa de tip STNB minim $\varnothing 8/150 \times \varnothing 8/150$.

- Considering that the structures are located in a seismic zone with $a_g=0.30g$ and aligning with the requirements of the P100/1-2013 code, which specifies the maximum number of floors permitted for URM-type constructions, and considering the observed degradation in masonry walls, we propose reinforcing the masonry walls with reinforced jacketing, with a minimum thickness of 8 cm on both sides and STNB mesh of at least $\varnothing 8/150 \times \varnothing 8/150$.

- La suprastructura :
 - Se desfac tencuielile se curata rosturile pe o adancime de 15-20mm.
 - Se vor injecta toate fisurile descoperite in zidarie/elemente beton;

- For the superstructure :
 - Existing plaster will be removed, and the joints will be cleaned to a depth of 15-20 mm.
 - All cracks discovered in the masonry or concrete elements will be injected.
