CLIENT / CLIENT: C.N.C.F. "C.F.R." - S.A.

Denunțare desen / Drawing Title: Pasaj Inferior / Lower Passage km 171+485.00

Remedierea defectelor de suprafață mare și adâncime la betonare
Retrieval of defects with large surface and high depth in concrete

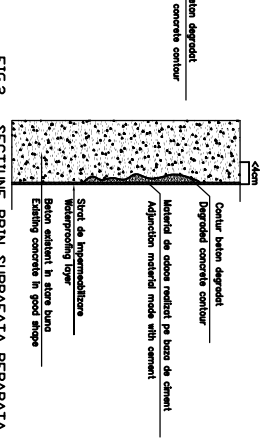
FIG2. SECȚIUNE PRIN SUPRAFATA REPARATA
SECTION THRU THE REPAIRED SURFACE

- Technology of repair works to the concrete areas with type DS, damaged, acc. to Clap.57:
- Identifying and marking the damaged concrete areas;
 - Cleaning with compressed air steam;
 - Marking on the concrete areas and preparing it with other forms or moulds;
 - Protecting the one against sudden expansion of water;
 - Preparing the repair mortar and placing it in the formwork;
 - Protecting the surface with a protective layer on the entire repaired area (see detail).

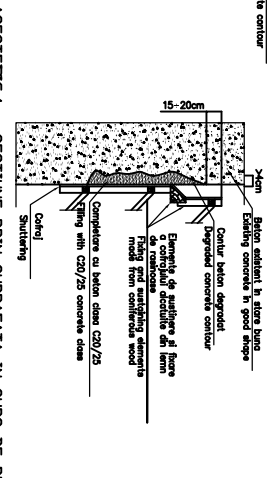
FIG4. SECȚIUNE PRIN SUPRAFATA IN CURS DE REPARARE
SECTION THRU THE REPAIRED SURFACE

- Technology of repair works to the concrete areas with type DAS, damaged, acc. to Clap.57, fig.11 și fig.12:
- Identifying and marking the damaged concrete areas;
 - Cleaning with compressed air steam;
 - Marking on the concrete areas and preparing it with other forms or moulds;
 - Protecting the one against sudden expansion of water;
 - Preparing the repair mortar and placing it in the formwork;
 - Protecting the surface with a protective layer on the entire repaired area (see detail).

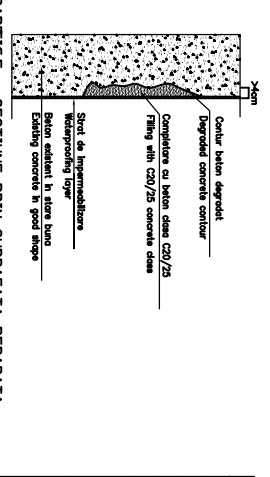
FIG5. SECȚIUNE PRIN SUPRAFATA REPARATA
SECTION THRU THE REPAIRED SURFACE

- Technology of repair works to the concrete areas with type DAS, damaged, acc. to Clap.57, fig.11 și fig.12:
- Identifying and marking the damaged concrete areas;
 - Cleaning with compressed air steam;
 - Marking on the concrete areas and preparing it with other forms or moulds;
 - Protecting the one against sudden expansion of water;
 - Preparing the repair mortar and placing it in the formwork;
 - Protecting the surface with a protective layer on the entire repaired area (see detail).
