DENUMIRE PROIECT/ DENUMIRE LUCRARE: GIURGIU NORD FRONTIERĂ Lot 2 - MODERNIZAREA INFRASTRUCTURII DE CALE FERATA DINTRE STATILE CF BUCURESTI NORD - GIURGIU NORD - GIURGIU NORD FRONTIERA

PROJECT TITLE/ WORKS TITLE: Lot 2 - MODERNIZATION OF THE RAILWAY NORTH BORDER JILAVA - GIURGIU NORTH - GIURGIU NORTH BORDER

DENUMIRE PLAN/ DRAWING TITLE: RELEVU PODET KM 34 +078 CULVERT SURVEY KM 34+078

COD PLAN/ CODIFICATION SYSTEM: ET 207 Lot 2 19 Pd14 01 00

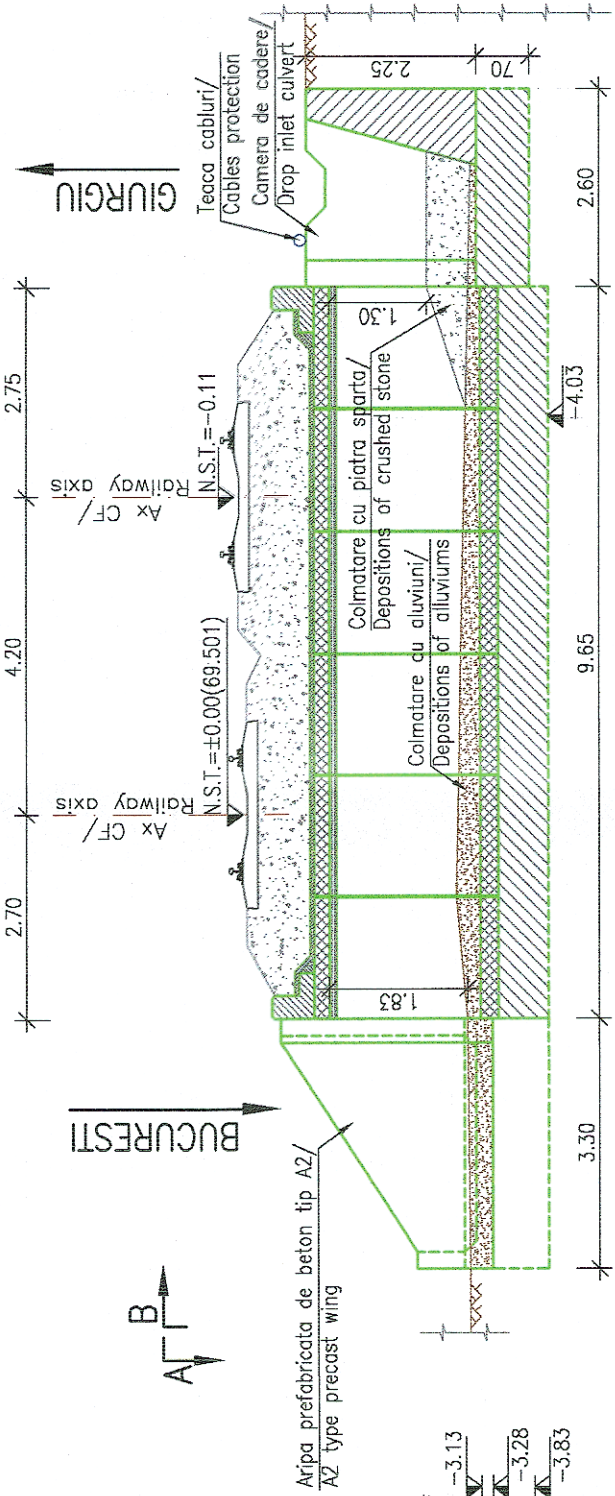
SECTIUNE LONGITUDINALA C-C/C-C LONGITUDINAL SECTION

Pavaj din anrocamente legate cu var hidroalic, in stare buna / Good shape water lime binded riprap pavement

Umplutura din argila prafoasa, cenusie, in amestec cu pietris si rara piatra sparta, plastic vartoasa / Filling made of brown, dusty clay, mixed with gravel and rare crushed stone, plastic-stiff

Argila prafoasa, cenusie, plastic vartoasa / Brown-grey, dusty clay, plastic stiff
