DENUMIRE PROIECT/ DENUMIRE LUCRARE: GIURGIU NORD FRONTIERĂ Lot 2 - MODERNIZAREA INFRASTRUCTURII DE CALE FERATA DINTRE STATILE CF BUCURESTI NORD - GIURGIU NORD - GIURGIU NORD FRONTIERA

PROJECT TITLE/ WORKS TITLE: Lot 2 - MODERNIZATION OF THE RAILWAY NORTH BORDER JILAVA - GIURGIU NORTH - GIURGIU NORTH BORDER

DENUMIRE PLAN/ DRAWING TITLE: RELEVU PODET KM 34 +078 CULVERT SURVEY KM 34+078

COD PLAN/ CODIFICATION SYSTEM: ET 207 Lot 2 19 Pd14 01 00

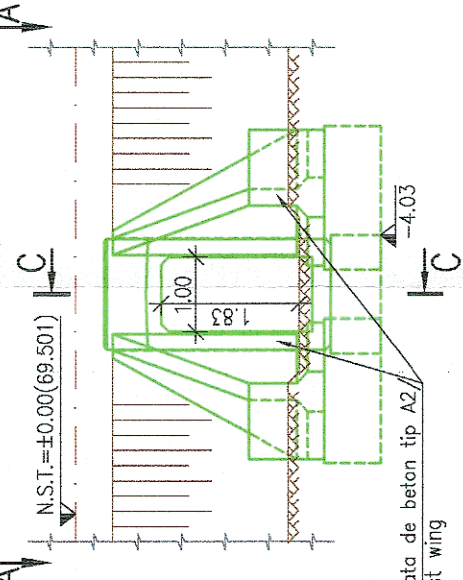
VEDERE B-B/B-B VIEW

Pavaj din anrocamente legate cu var hidroalic, in stare buna / Good shape water lime binded riprap pavement

Umplutura din argila prafoasa, cenusie, in amestec cu pietris si rara piatra sparta, plastic vartoasa / Filling made of brown, dusty clay, mixed with gravel and rare crushed stone, plastic-stiff

Argila prafoasa, cenusie, plastic vartoasa / Brown-grey, dusty clay, plastic stiff

Aripa prefabricata de beton tip A2 / A2 type precast wing

Camera de cadere / Drop inlet culvert
