STATIA C.F. MOGOSOAIA / *MOGOSOAIA RAILWAY STATION*  
CLADIRE CED / *CED BUILDING*

| Denumire / Title<br><b>STATIA C.F. MOGOSOAIA.<br/>CLADIRE CED. LUCRARI DE REPARATII /<br/>MOGOSOAIA RAILWAY STATION.<br/>CED BUILDING. REPAIR WORKS</b> | | | Scara / Scale<br>1:100 |

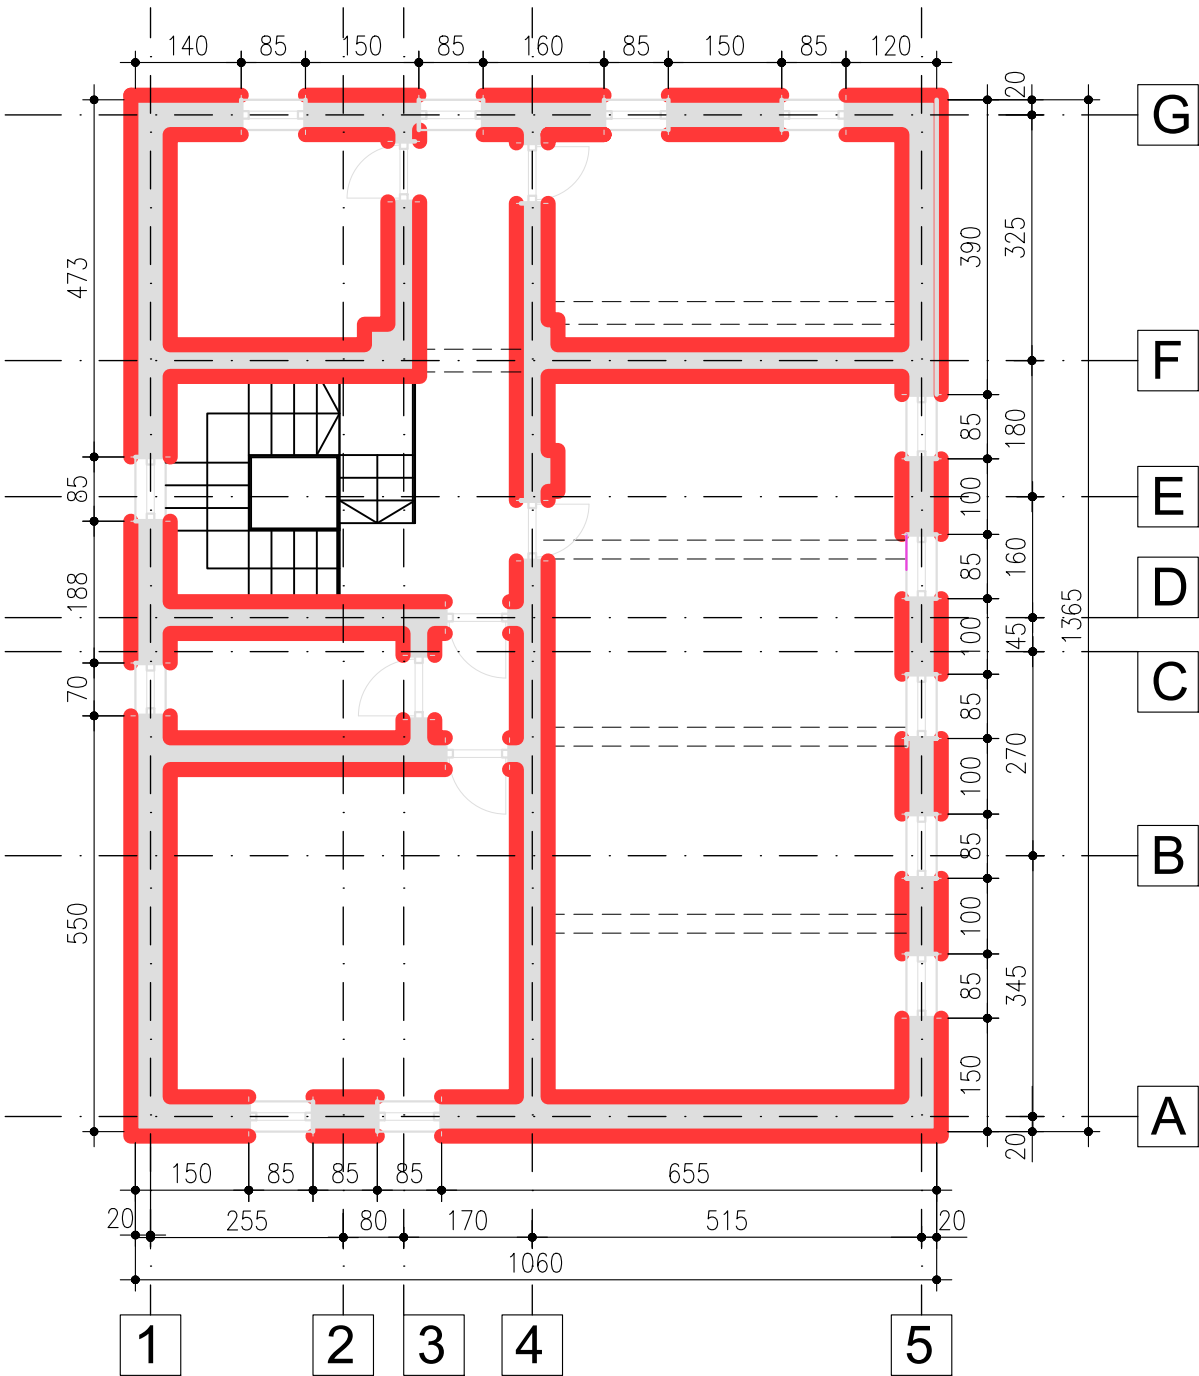
Lucrari de reparatii - Plan consolidare pereti etaj 1 / *Repair works - 1st floor wall consolidation plan*

TEHNOLOGIE DE REALIZARE

- La infrastructura:
  - Se extinde verificarea fundatiilor atat ca adancime cat si ca latime plus aspect structural. In cazul in care se constata cote de fundatie in teren umplutura sau deasupra cotei de inghet, se vor realiza subzidiri locale in ploturi. In cazul in care se constata fisuri, se vor realiza reparatii prin injectari.

- Realizare hidroizolatie exterioara la fundatii
  - Realizare sistem de tip Freeztec pentru impiedicarea urcarii apei prin capilaritate;
  - Refacere tencuieli degradate prin accesiunea apei in zidarie;

- La suprastructura :
  - Se desfac tencuielile se curata rosturile pe o adancime de 15–20mm.
  - Se vor injecta toate fisurile descoperite in zidarie/elemente beton;

- Tinand cont ca constructiile se afla in zona seismica cu  $a_g=0.30g$  si coreland acesta cu cerintele normativului P100/1–2013 in care se specifica numarul maxim de niveluri acceptate pentru constructiile de tip ZNA, tinad cont de degradarile observate in peretii de zidarie, pentru imbunatatirea conditiilor de siguranta structurala propunem consolidarea peretilor de zidarie cu camasiuala armata minim 5–6cm grosime pe ambele parti si plasa de tip STNB minim  $\varnothing 6/100 \times \varnothing 6/100$ .

EXECUTION TECHNOLOGY

- For the infrastructure:
  - The foundation inspection will be extended to verify both depth and width, as well as structural aspects. If the foundation levels are found to be in fill soil or above the frost depth, local underpinning in sections will be carried out. If cracks or are found, repairs will be made through injection techniques.

- Installation of external waterproofing on foundations.
  - Implementation of a Freeztec system to prevent capillary rise of water.
  - Restoration of degraded plaster affected by water infiltration into the masonry.

- For the superstructure :
  - Existing plaster will be removed, and the joints will be cleaned to a depth of 15–20 mm.
  - All cracks discovered in the masonry or concrete elements will be injected.

- Considering that the structures are located in a seismic zone with  $a_g=0.30g$  and aligning with the requirements of the P100/1–2013 code, which specifies the maximum number of floors permitted for URM–type constructions, and considering the observed degradation in masonry walls, we propose reinforcing the masonry walls with reinforced jacketing, with a minimum thickness of 5–6 cm on both sides and STNB mesh of at least  $\varnothing 6/100 \times \varnothing 6/100$ .
