STATIA C.F. OTOPENI / *OTOPENI RAILWAY STATION*  
CLADIRE CED / *CED BUILDING*

Lucrari de reparatii - Plan consolidare pereti etaj 1 /  
*Repair works - 1st floor wall consolidation plan*

| Denumire / Title | STATIA C.F. OTOPENI.<br>CLADIRE CED. LUCRARI DE REPARATII /<br>OTOPENI RAILWAY STATION.<br>CED BUILDING. REPAIR WORKS | | Scara / Scale<br>1:100 |

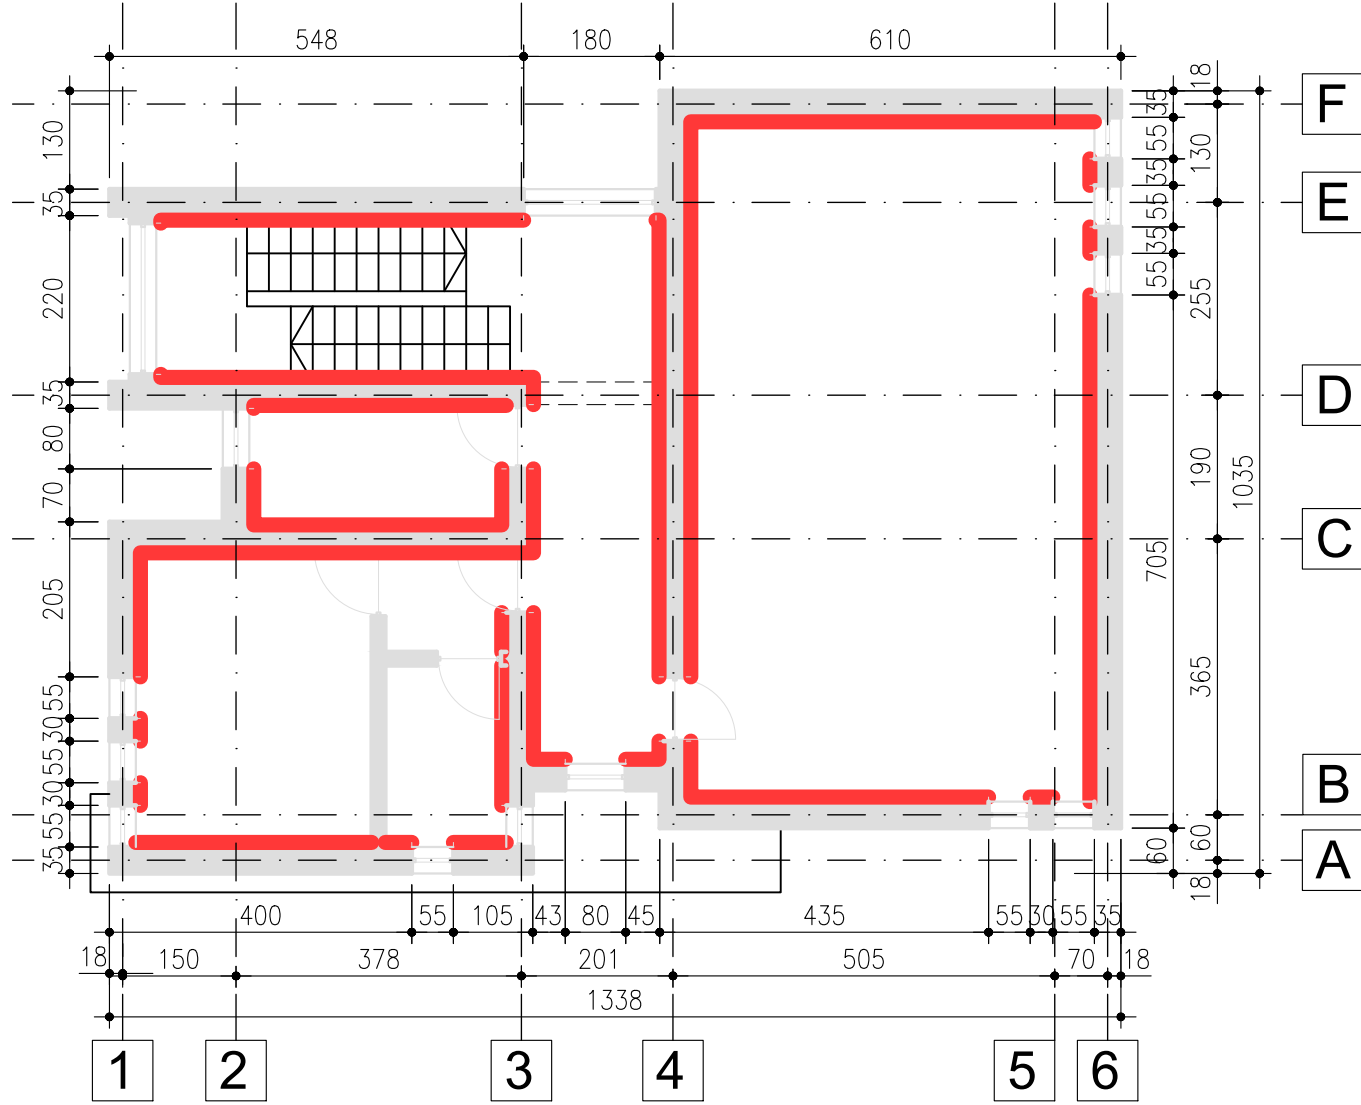
TEHNOLOGIE DE REALIZARE

- La infrastructura:
  - Se extinde verificarea fundatiilor atat ca adancime cat si ca latime plus aspect structural. In cazul in care se constata cote de fundatie in teren umplutura sau deasupra cotei de inghet, se vor realiza subzidiri locale in ploturi. In cazul in care se constata fisuri, se vor realiza reparatii prin injectari.

- Realizare hidroizolatie exterioara la fundatii
  - Realizare sistem de tip Freezteq pentru impiedicarea urcarii apei prin capilaritate;
  - Refacere tencuieli degradate prin accesiunea apei in zidarie;

- La suprastructura :
  - Se desfac tencuielile se curata rosturile pe o adancime de 15–20mm.
  - Se vor injecta toate fisurile descoperite in zidarie/elemente beton;

- Tinand cont ca constructiile se afla in zona seismica cu  $a_g=0.30g$  si coreland acesta cu cerintele normativului P100/1–2013 in care se specifica numarul maxim de niveluri acceptate pentru constructiile de tip ZNA, tinad cont de degradarile observate in peretii de zidarie, pentru imbunatatirea conditiilor de siguranta structurala propunem consolidarea peretilor de zidarie cu camasuiala armata minim 5–6cm grosime pe ambele parti si plasa de tip STNB minim Ø8/150 x Ø8/150. Avand in vedere ca constructia este reabilitata la exterior si tinand cont de starea generala a constructiei in ansamblu, lucrarile de camasuire se vor realiza strict la interior pentru peretii exteriori si pe ambele fete pentru peretii interiori.

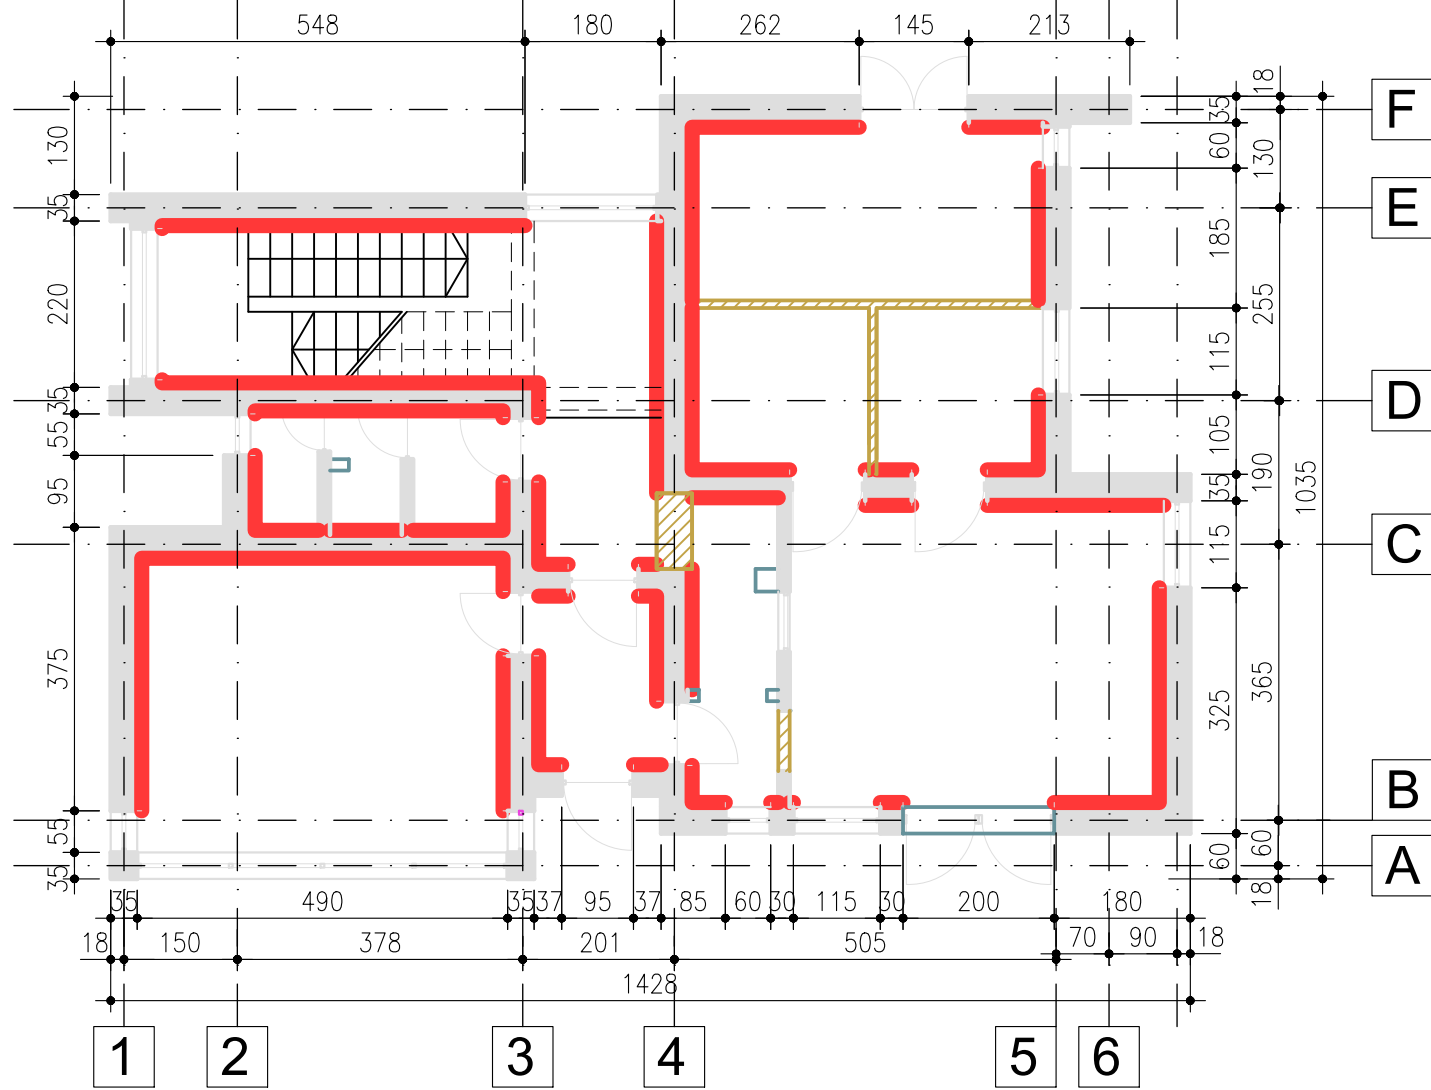
Lucrari de reparatii - Plan consolidare pereti parter /  
*Repair works - ground floor wall consolidation plan*

EXECUTION TECHNOLOGY

- For the infrastructure:
  - The foundation inspection will be extended to verify both depth and width, as well as structural aspects. If the foundation levels are found to be in fill soil or above the frost depth, local underpinning in sections will be carried out. If cracks or are found, repairs will be made through injection techniques.

- Installation of external waterproofing on foundations.
  - Implementation of a Freezteq system to prevent capillary rise of water.
  - Restoration of degraded plaster affected by water infiltration into the masonry.

- For the superstructure :
  - Existing plaster will be removed, and the joints will be cleaned to a depth of 15–20 mm.
  - All cracks discovered in the masonry or concrete elements will be injected.

- Considering that the structures are located in a seismic zone with  $a_g=0.30g$  and aligning with the requirements of the P100/1–2013 code, which specifies the maximum number of floors permitted for URM–type constructions, and considering the observed degradation in masonry walls, we propose reinforcing the masonry walls with reinforced jacketing, with a minimum thickness of 5–6 cm on both sides and STNB mesh of at least Ø8/150 x Ø8/150. Since the building has been rehabilitated externally and given the overall structural condition, the jacketing work will be limited to the interior side of the exterior walls and both sides of the interior walls.
