STATIA C.F. PASAREA / PASAREA RAILWAY STATION

CLADIRE CED / CED BUILDING

**"Modernizarea liniilor și instalațiilor din Complexul Feroviar București"
Studiul de fezabilitate**

Denumire / Title
**STATIA C.F. PASAREA.
CLADIRE CED. LUCRARI DE REPARATII /
PASAREA RAILWAY STATION.
CED BUILDING. REPAIR WORKS**

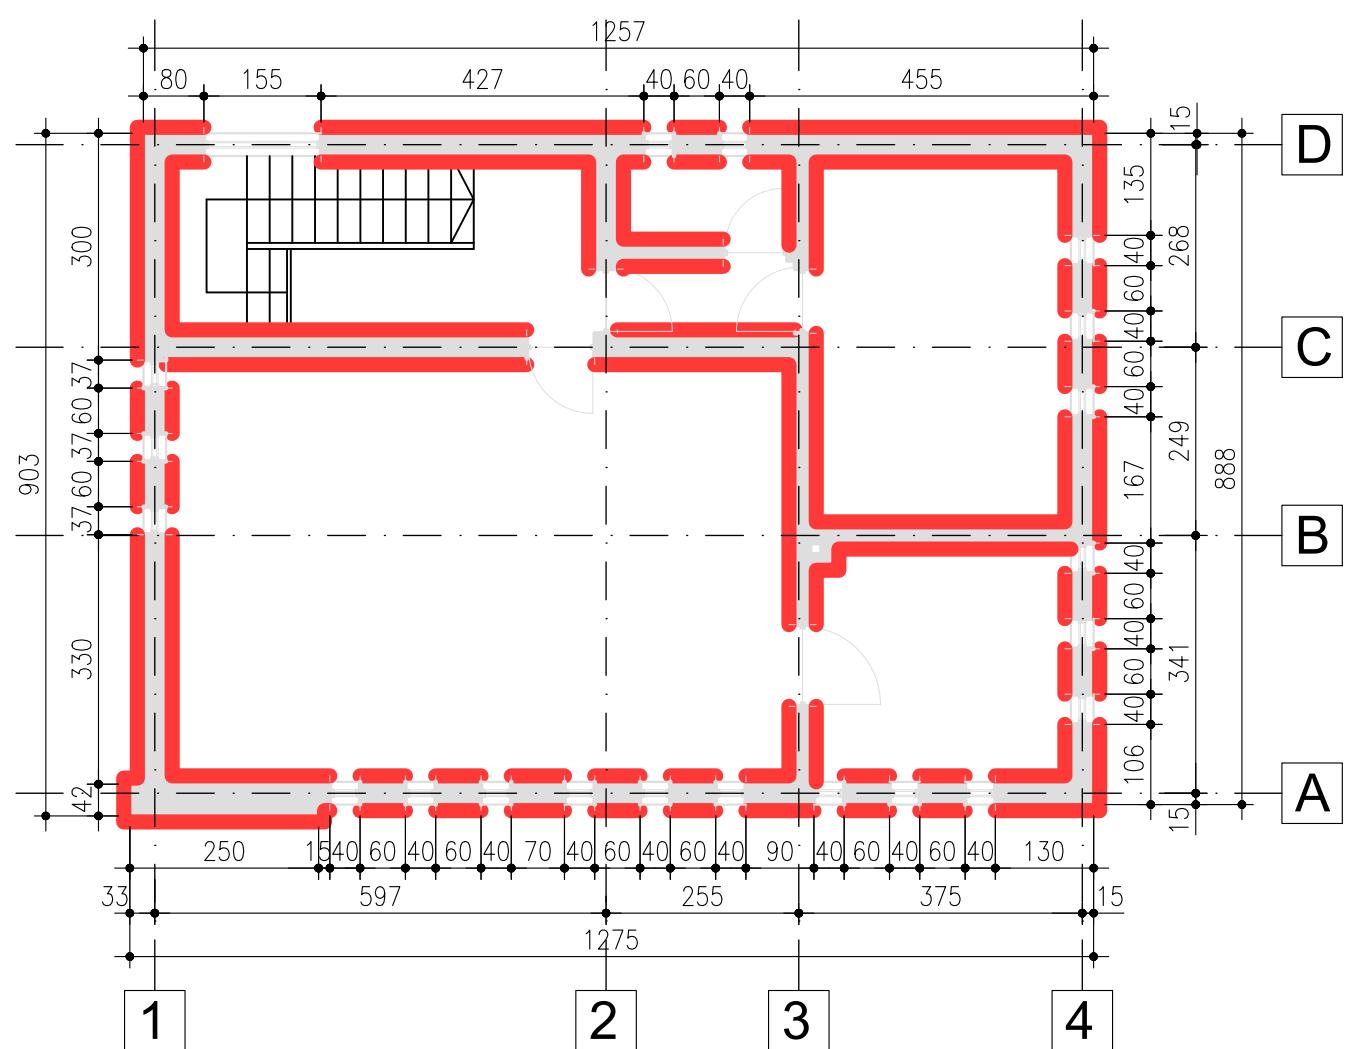
Lucrari de reparatii - Plan consolidare pereti etaj 1 /

Repair works - 1st floor wall consolidation plan

Scara/Scale 1:100

- La suprastructura :
 - Se desfac tencuiile se curata rosturile pe o adancime de 15–20mm.
 - Se vor injecta toate fisurile descoperite in zidarie/elemente beton;

- Tinand cont ca constructiile se afla in zona seismică cu $ag=0.30g$ si coreland acesta cu cerintele normativului P100/1–2013 in care se specifica numarul maxim de niveluri acceptate pentru constructiile de tip ZNA, tinand cont de degradarile observate in peretii de zidarie, pentru imbunatatirea conditiilor de siguranta structurala propunem consolidarea peretilor de zidarie cu camausuala armata minim 8cm grosime pe ambele parti si plasa de tip STNB minim Ø8/150 x Ø8/150.

- For the superstructure :
 - Existing plaster will be removed, and the joints will be cleaned to a depth of 15–20 mm.
 - All cracks discovered in the masonry or concrete elements will be injected.

- Considering that the structures are located in a seismic zone with $ag=0.30g$ and aligning with the requirements of the P100/1–2013 code, which specifies the maximum number of floors permitted for URM-type constructions, and considering the observed degradation in masonry walls, we propose reinforcing the masonry walls with reinforced jacking, with a minimum thickness of 8 cm on both sides and STNB mesh of at least Ø8/150 x Ø8/150.

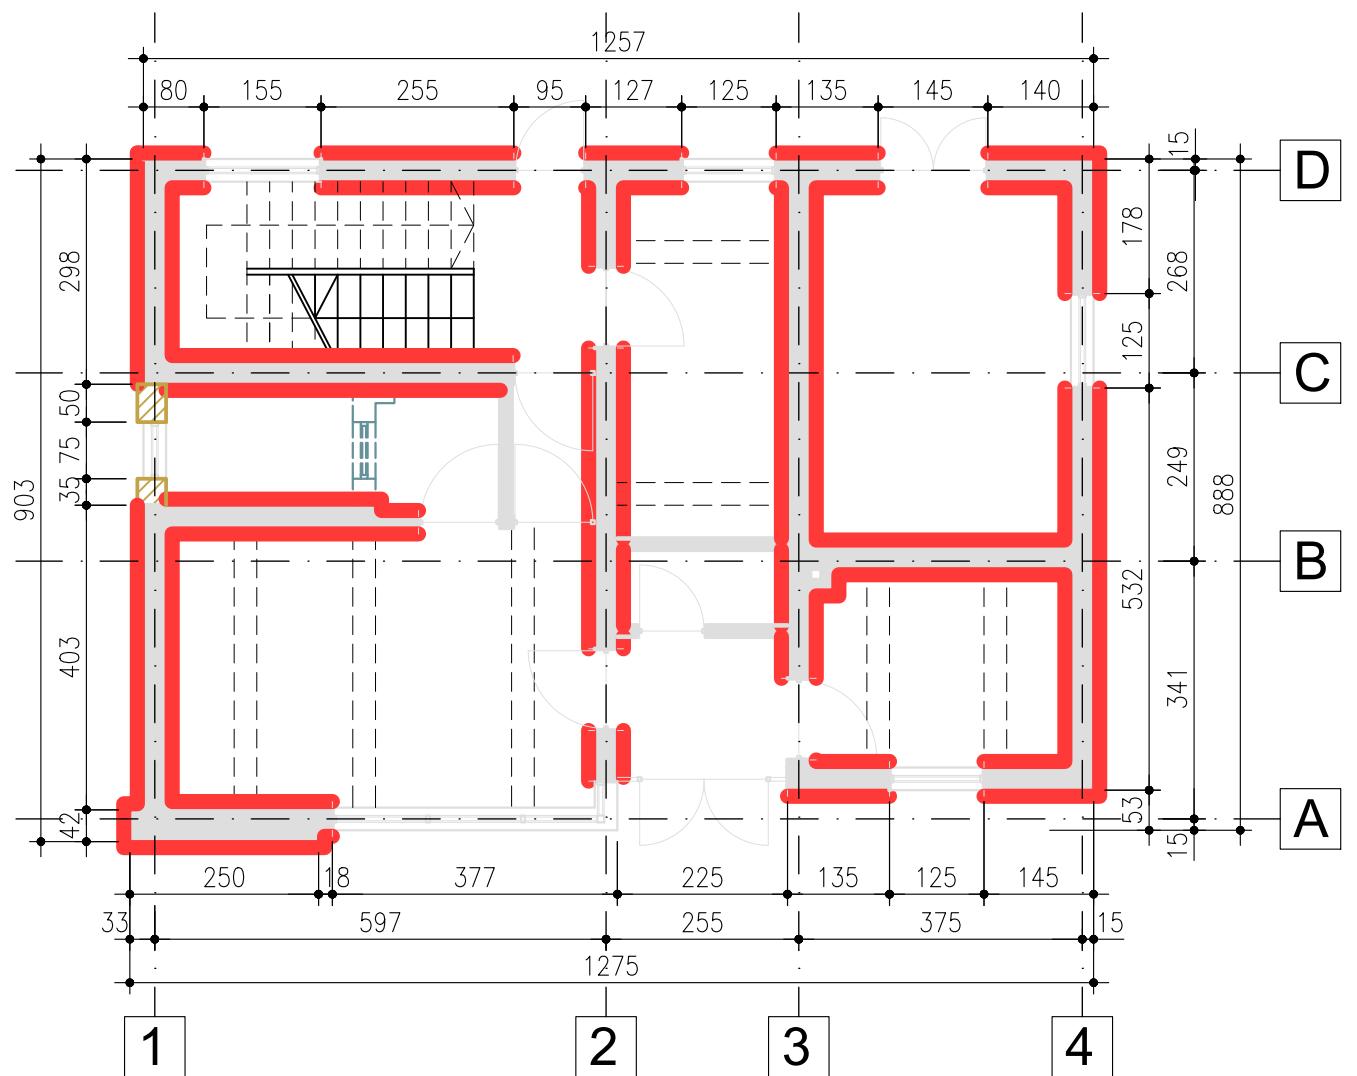
Lucrari de reparatii - Plan consolidare pereti parter /

Repair works - ground floor wall consolidation plan

Scara/Scale 1:100

- La infrastructura:
 - Se extinde verificarea fundatiilor atat ca adancime cat si ca latime plus aspect structural. In cazul in care se constata cote de fundatie in teren umplutura sau deasupra cotei de inghet, se vor realiza subzidiri locale in ploturi. In cazul in care se constata fisuri, se vor realiza reparatii prin injectari.

- Realizare hidroizolatie exteriora la fundatii
 - Realizare sistem de tip Freeztec pentru impiedicarea urcarii apei prin capilaritate;
 - Refacere tencuieli degradate prin accesiunea apei in zidarie;

- For the infrastructure:
 - The foundation inspection will be extended to verify both depth and width, as well as structural aspects. If the foundation levels are found to be in fill soil or above the frost depth, local underpinning in sections will be carried out. If cracks or are found, repairs will be made through injection techniques.

- Installation of external waterproofing on foundations.
 - Implementation of a Freeztec system to prevent capillary rise of water.
 - Restoration of degraded plaster affected by water infiltration into the masonry.
