STATIA C.F. BUCURESTI SUD GRUPA CALATORI / BUCHAREST SOUTH RAILWAY STATION PASSENGER GROUP  
CLADIRE CALATORI / PASSENGER BUILDING

Lucrari de reparatii - Plan consolidare pereti etaj 1 / Repair works - 1st floor wall consolidation plan

| Denumire / Title<br><b>STATIA C.F. BUCURESTI SUD GRUPA CALATORI.<br/>CLADIRE CALATORI. LUCRARI DE REPARATII /<br/>BUCHAREST SOUTH RAILWAY STATION PASSENGER GROUP.<br/>PASSENGER BUILDING. REPAIR WORKS</b> | | | Scara / Scale<br>1:100 |

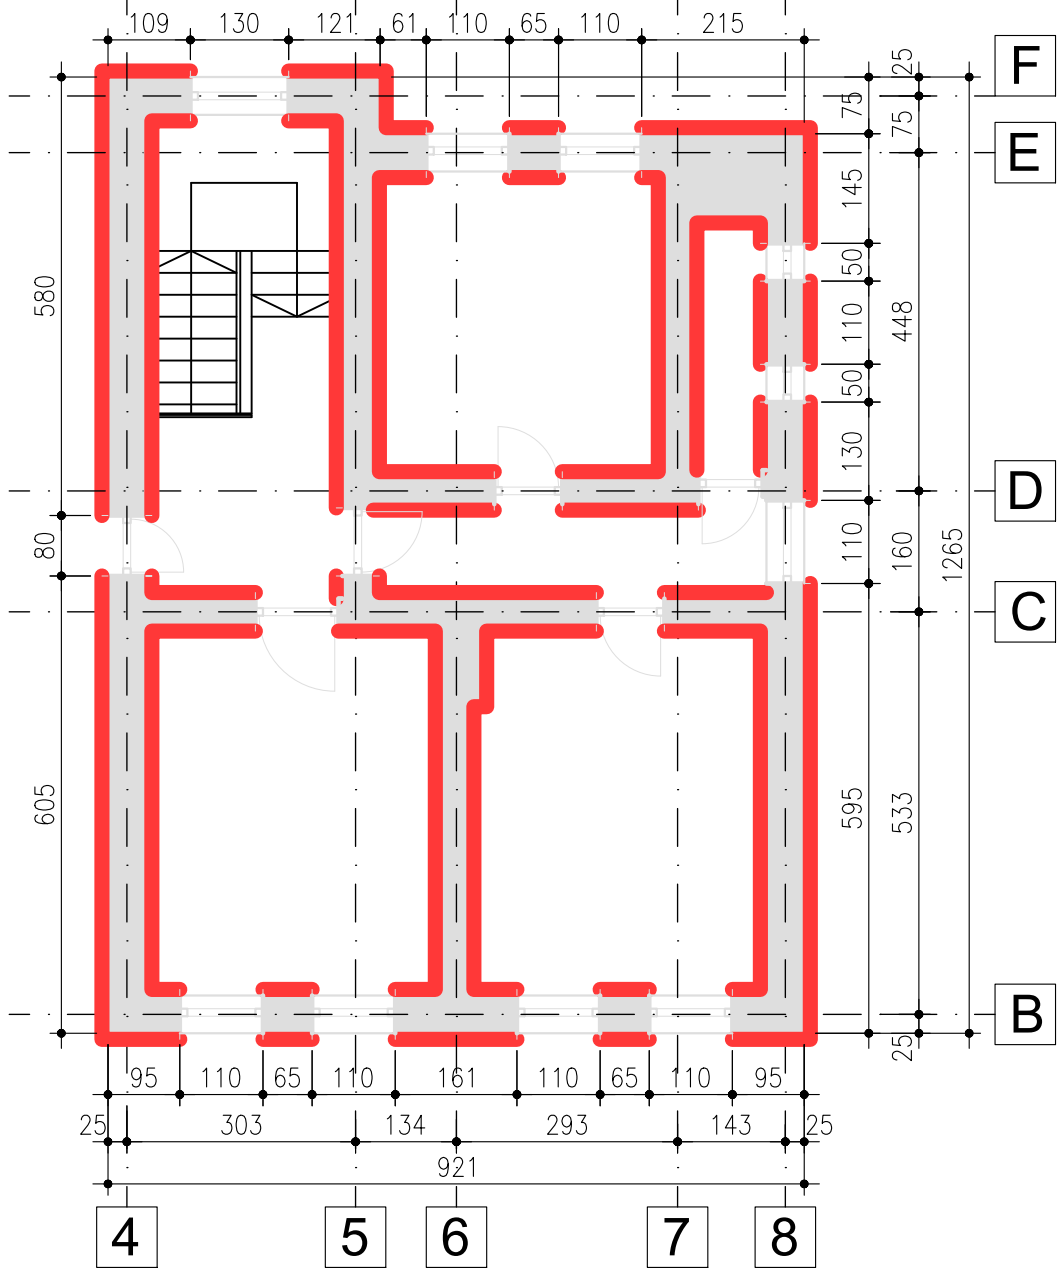
Scara/Scale 1:100

TEHNOLOGIE DE REALIZARE

- La infrastructura:
  - Se extinde verificarea fundatiilor atat ca adancime cat si ca latime plus aspect structural. In cazul in care se constata cote de fundatie in teren umplutura sau deasupra cotei de inghet, se vor realiza subzidiri locale in ploturi. In cazul in care se constata fisuri, se vor realiza reparatii prin injectari.

- Realizare hidroizolatie exterioara la fundatii
  - Realizare sistem de tip Freeztec pentru impiedicarea urcarii apei prin capilaritate;
  - Refacere tencuieli degradate prin accesiunea apei in zidarie;

- La suprastructura :
  - Se desfac tencuielile se curata rosturile pe o adancime de 15-20mm.
  - Se vor injecta toate fisurile descoperite in zidarie/elemente beton;

- Tinand cont ca constructiile se afla in zona seismica cu  $a_g=0.30g$  si coreland acesta cu cerintele normativului P100/1-2013 in care se specifica numarul maxim de niveluri acceptate pentru constructiile de tip ZNA, tinad cont de degradarile observate in peretii de zidarie, pentru imbunatatirea conditiilor de siguranta structurala propunem consolidarea peretilor de zidarie cu camasuiala armata minim 8cm grosime pe ambele parti si plasa de tip STNB minim Ø8/150 x Ø8/150.

EXECUTION TECHNOLOGY

- For the infrastructure:
  - The foundation inspection will be extended to verify both depth and width, as well as structural aspects. If the foundation levels are found to be in fill soil or above the frost depth, local underpinning in sections will be carried out. If cracks or are found, repairs will be made through injection techniques.

- Installation of external waterproofing on foundations.
  - Implementation of a Freeztec system to prevent capillary rise of water.
  - Restoration of degraded plaster affected by water infiltration into the masonry.

- For the superstructure :
  - Existing plaster will be removed, and the joints will be cleaned to a depth of 15-20 mm.
  - All cracks discovered in the masonry or concrete elements will be injected.

- Considering that the structures are located in a seismic zone with  $a_g=0.30g$  and aligning with the requirements of the P100/1-2013 code, which specifies the maximum number of floors permitted for URM-type constructions, and considering the observed degradation in masonry walls, we propose reinforcing the masonry walls with reinforced jacketing, with a minimum thickness of 8 cm on both sides and STNB mesh of at least Ø8/150 x Ø8/150.

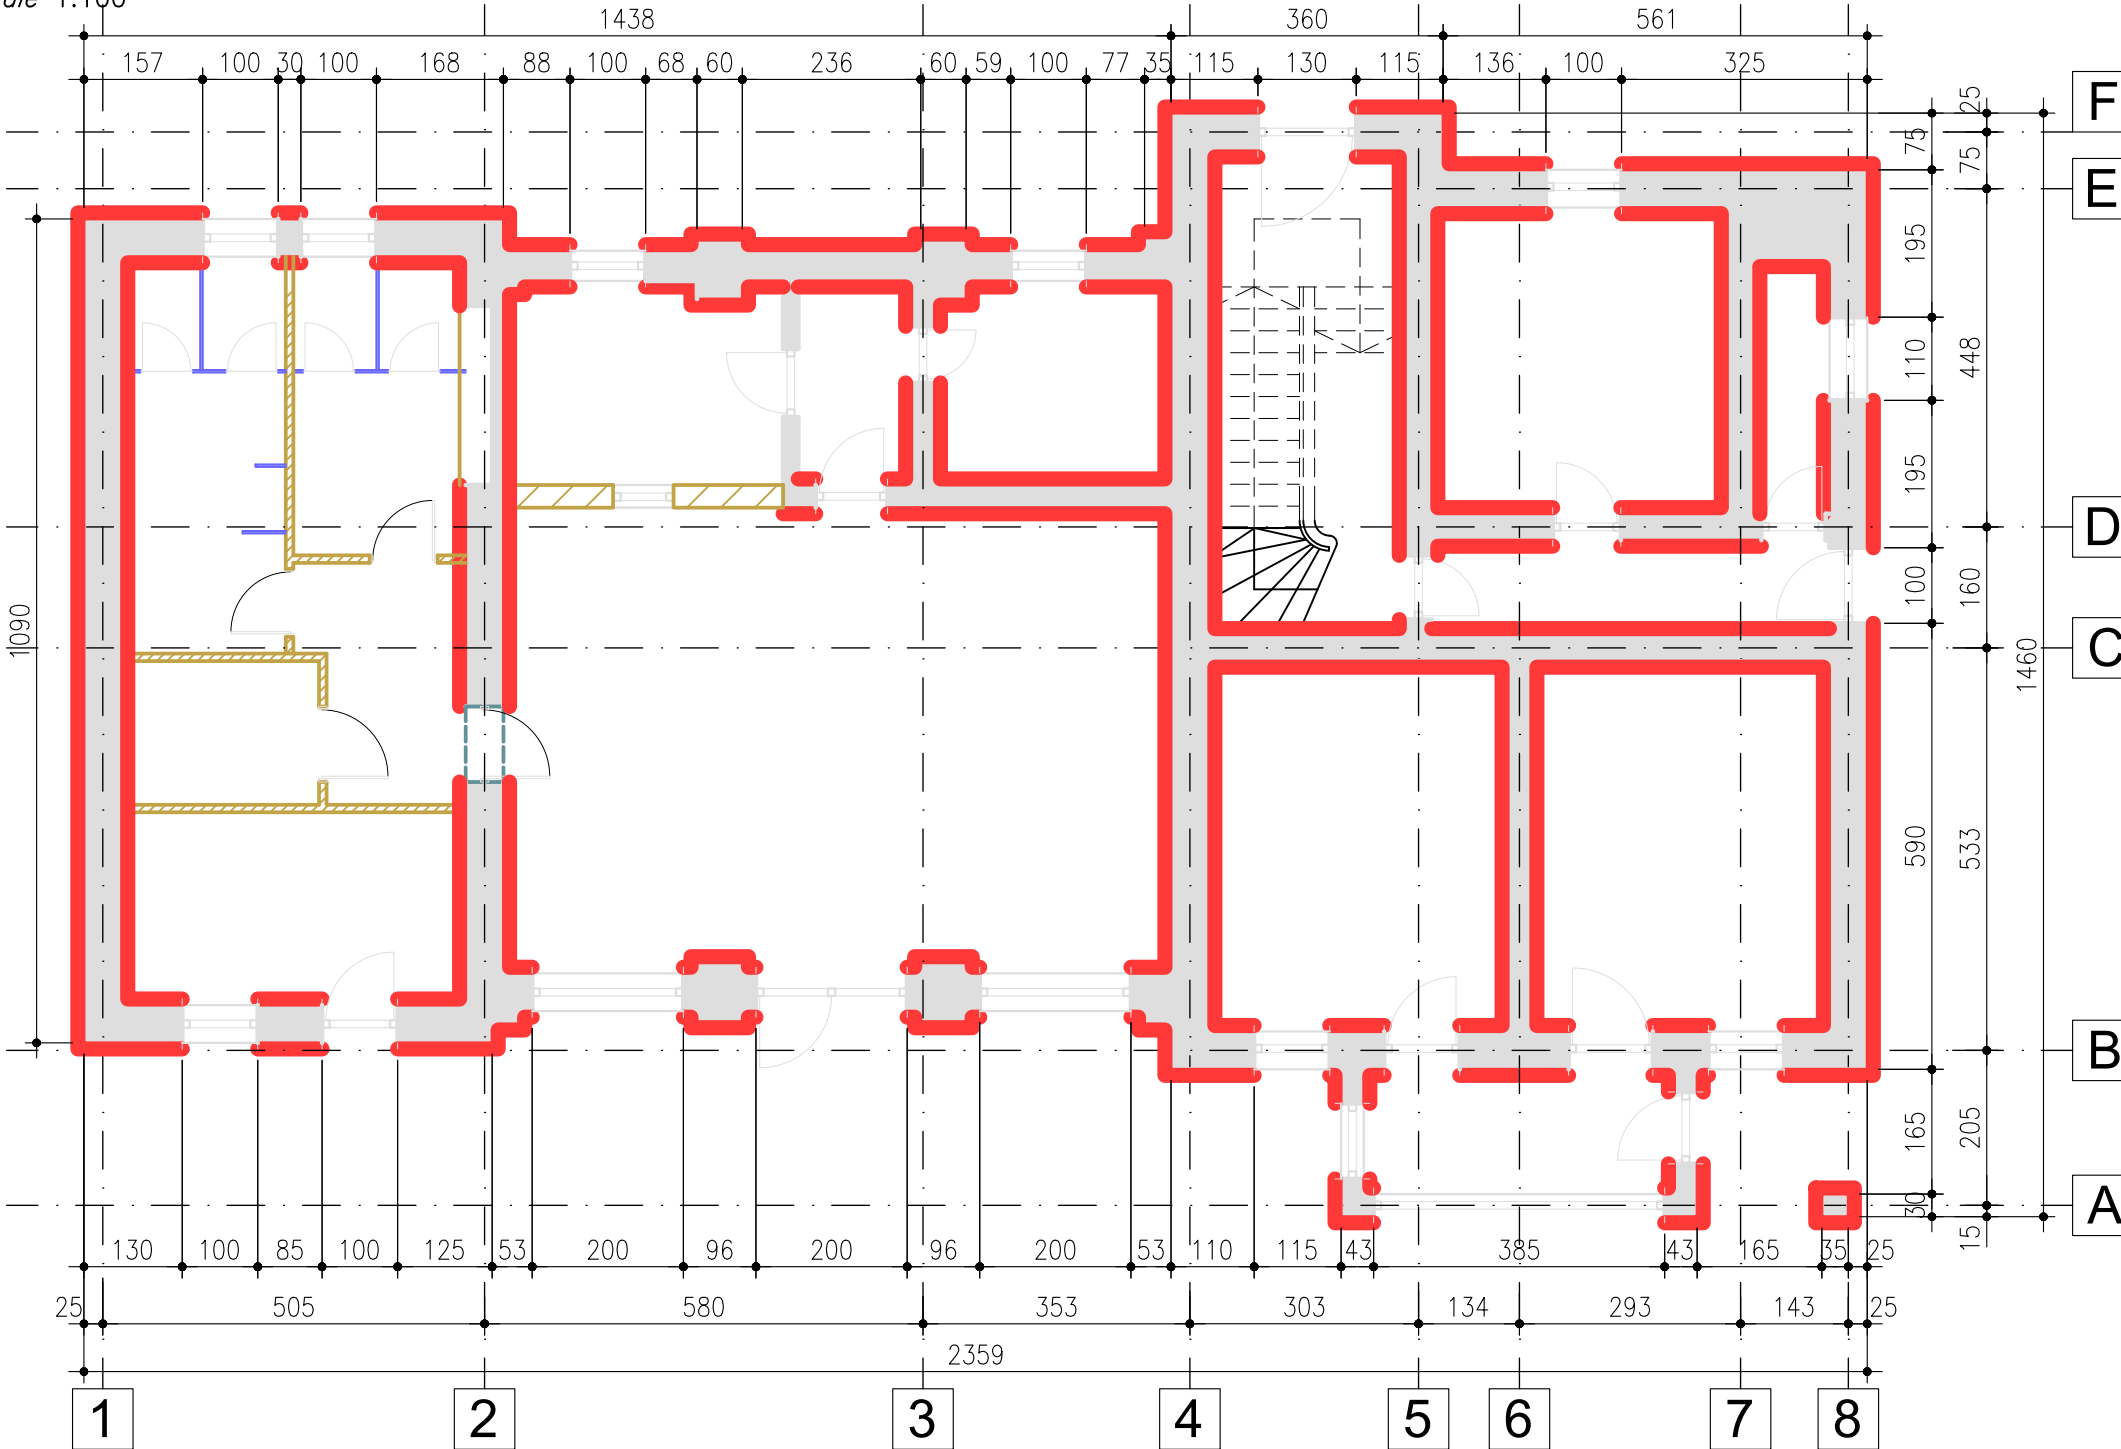
Lucrari de reparatii - Plan consolidare pereti parter / Repair works - ground floor wall consolidation plan

Scara/Scale 1:100
