P.M. GIULESTI / *GIULESTI RAILWAY STATION*  
CLADIRE CED / *CED BUILDING*  
Lucrari de reparatii - Plan consolidare pereti etaj 1 / *Repair works - 1st floor wall consolidation plan*

| P.M. GIULESTI.<br>CLADIRE CED. LUCRARI DE REPARATII /<br>GIULESTI M.P.<br>CED BUILDING. REPAIR WORKS | | | |

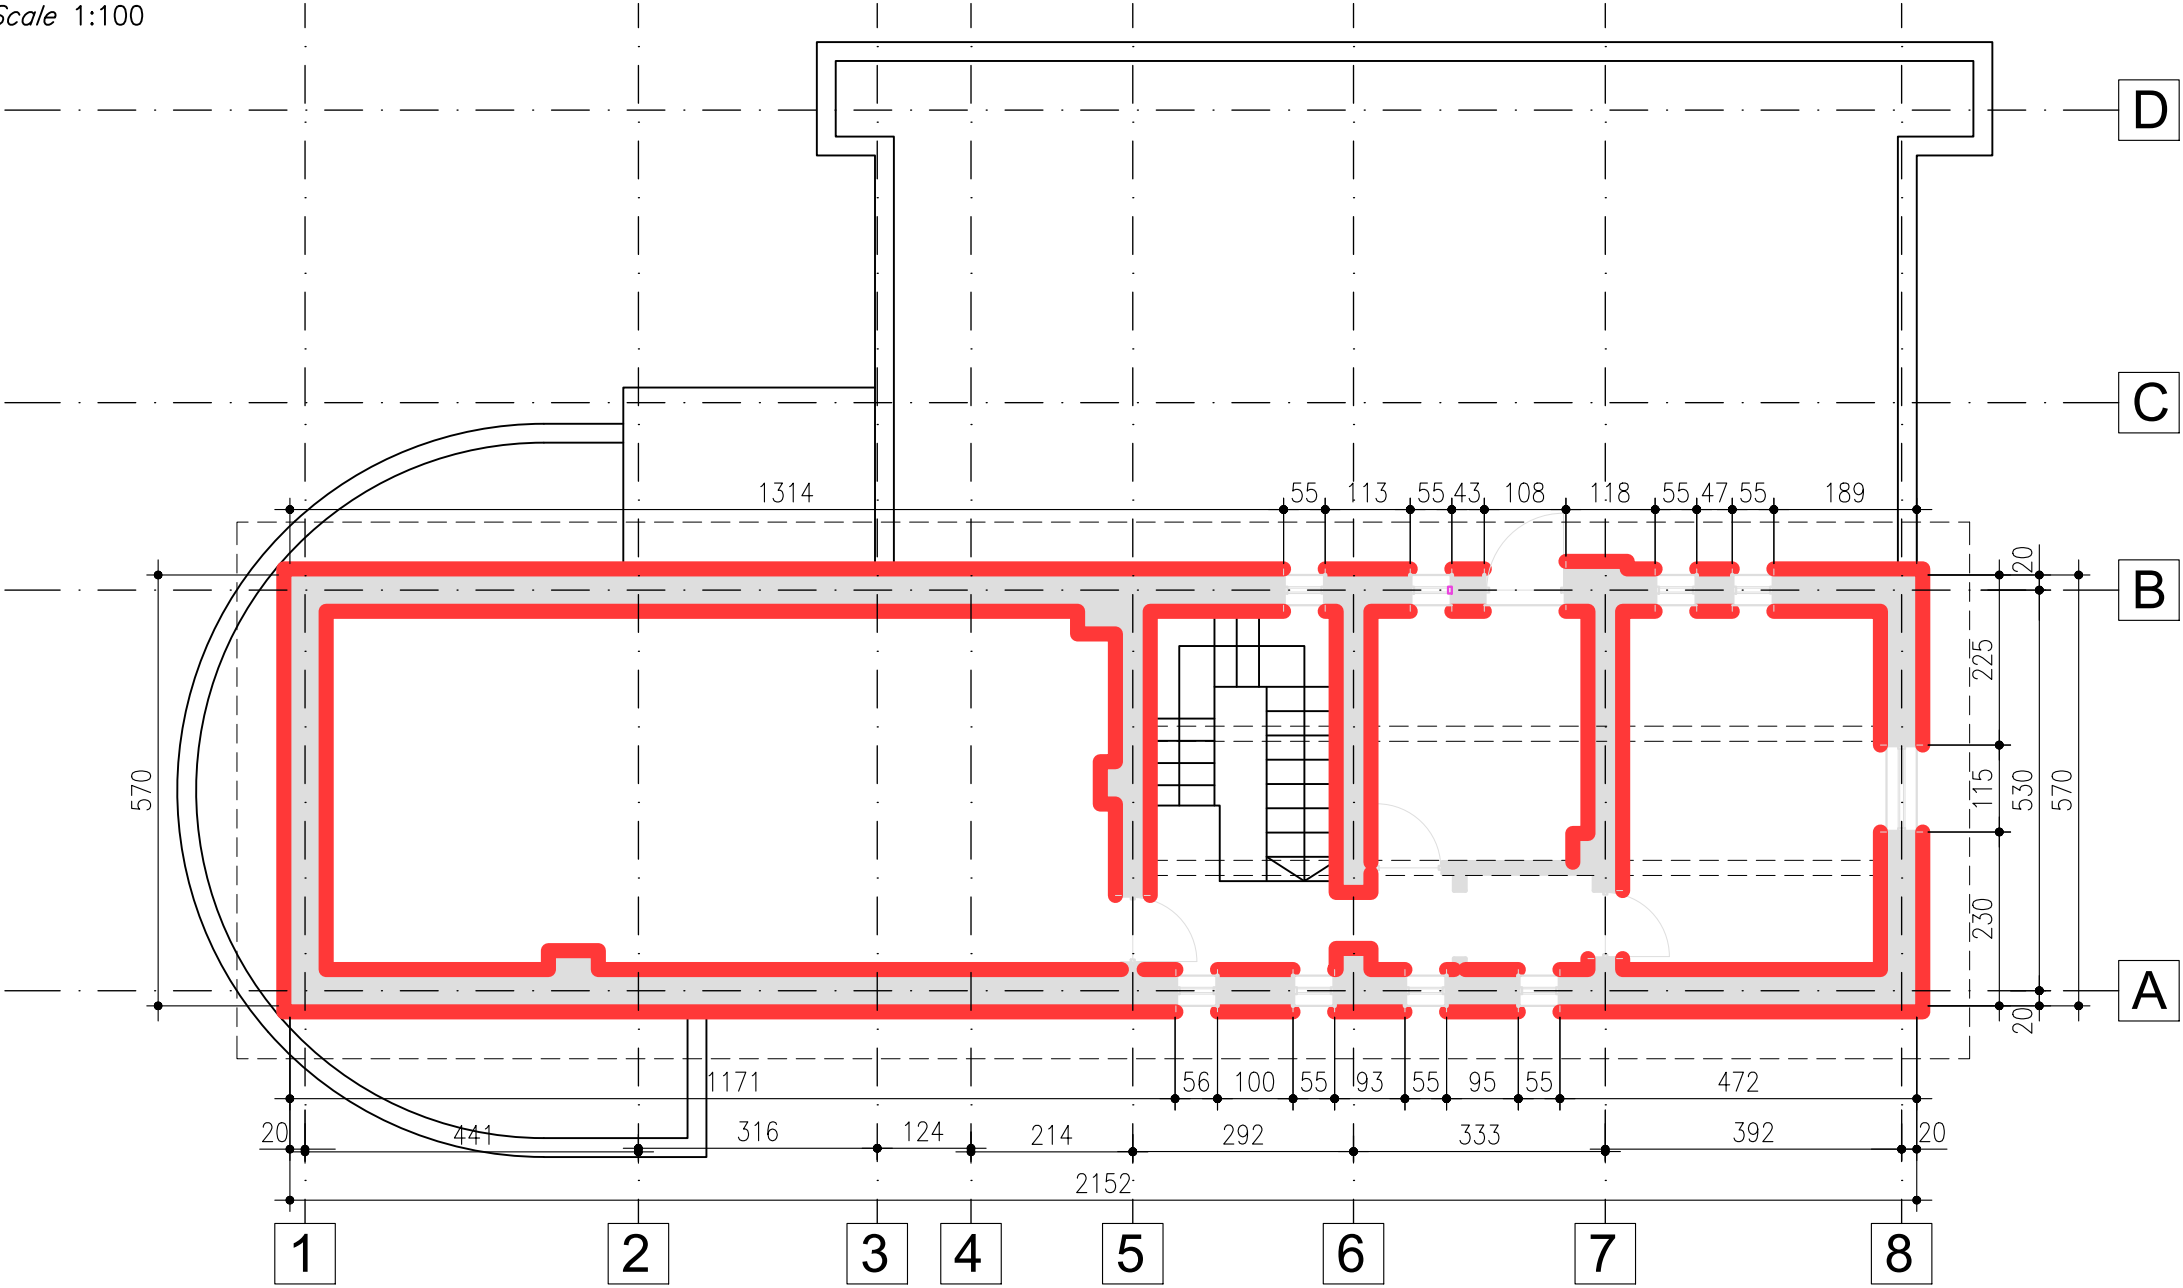
Scara/Scale 1:100

- La suprastructura :
  - Se desfac tencuielile se curata rosturile pe o adancime de 15–20mm.
  - Se vor injecta toate fisurile descoperite in zidarie/elemente beton;

- Tinand cont ca constructiile se afla in zona seismica cu  $a_g=0.30g$  si coreland acesta cu cerintele normativului P100/1–2013 in care se specifica numarul maxim de niveluri acceptate pentru constructiile de tip ZNA, tinad cont de degradarile observate in peretii de zidarie, pentru imbunatatirea conditiilor de siguranta structurala propunem consolidarea peretilor de zidarie cu camasiuala armata minim 8cm grosime pe ambele parti si plasa de tip STNB minim Ø8/150 x 8/150.

- For the superstructure :
  - Existing plaster will be removed, and the joints will be cleaned to a depth of 15–20 mm.
  - All cracks discovered in the masonry or concrete elements will be injected.

- Considering that the structures are located in a seismic zone with  $a_g=0.30g$  and aligning with the requirements of the P100/1–2013 code, which specifies the maximum number of floors permitted for URM–type constructions, and considering the observed degradation in masonry walls, we propose reinforcing the masonry walls with reinforced jacketing, with a minimum thickness of 8 cm on both sides and STNB mesh of at least Ø8/150 x 8/150.

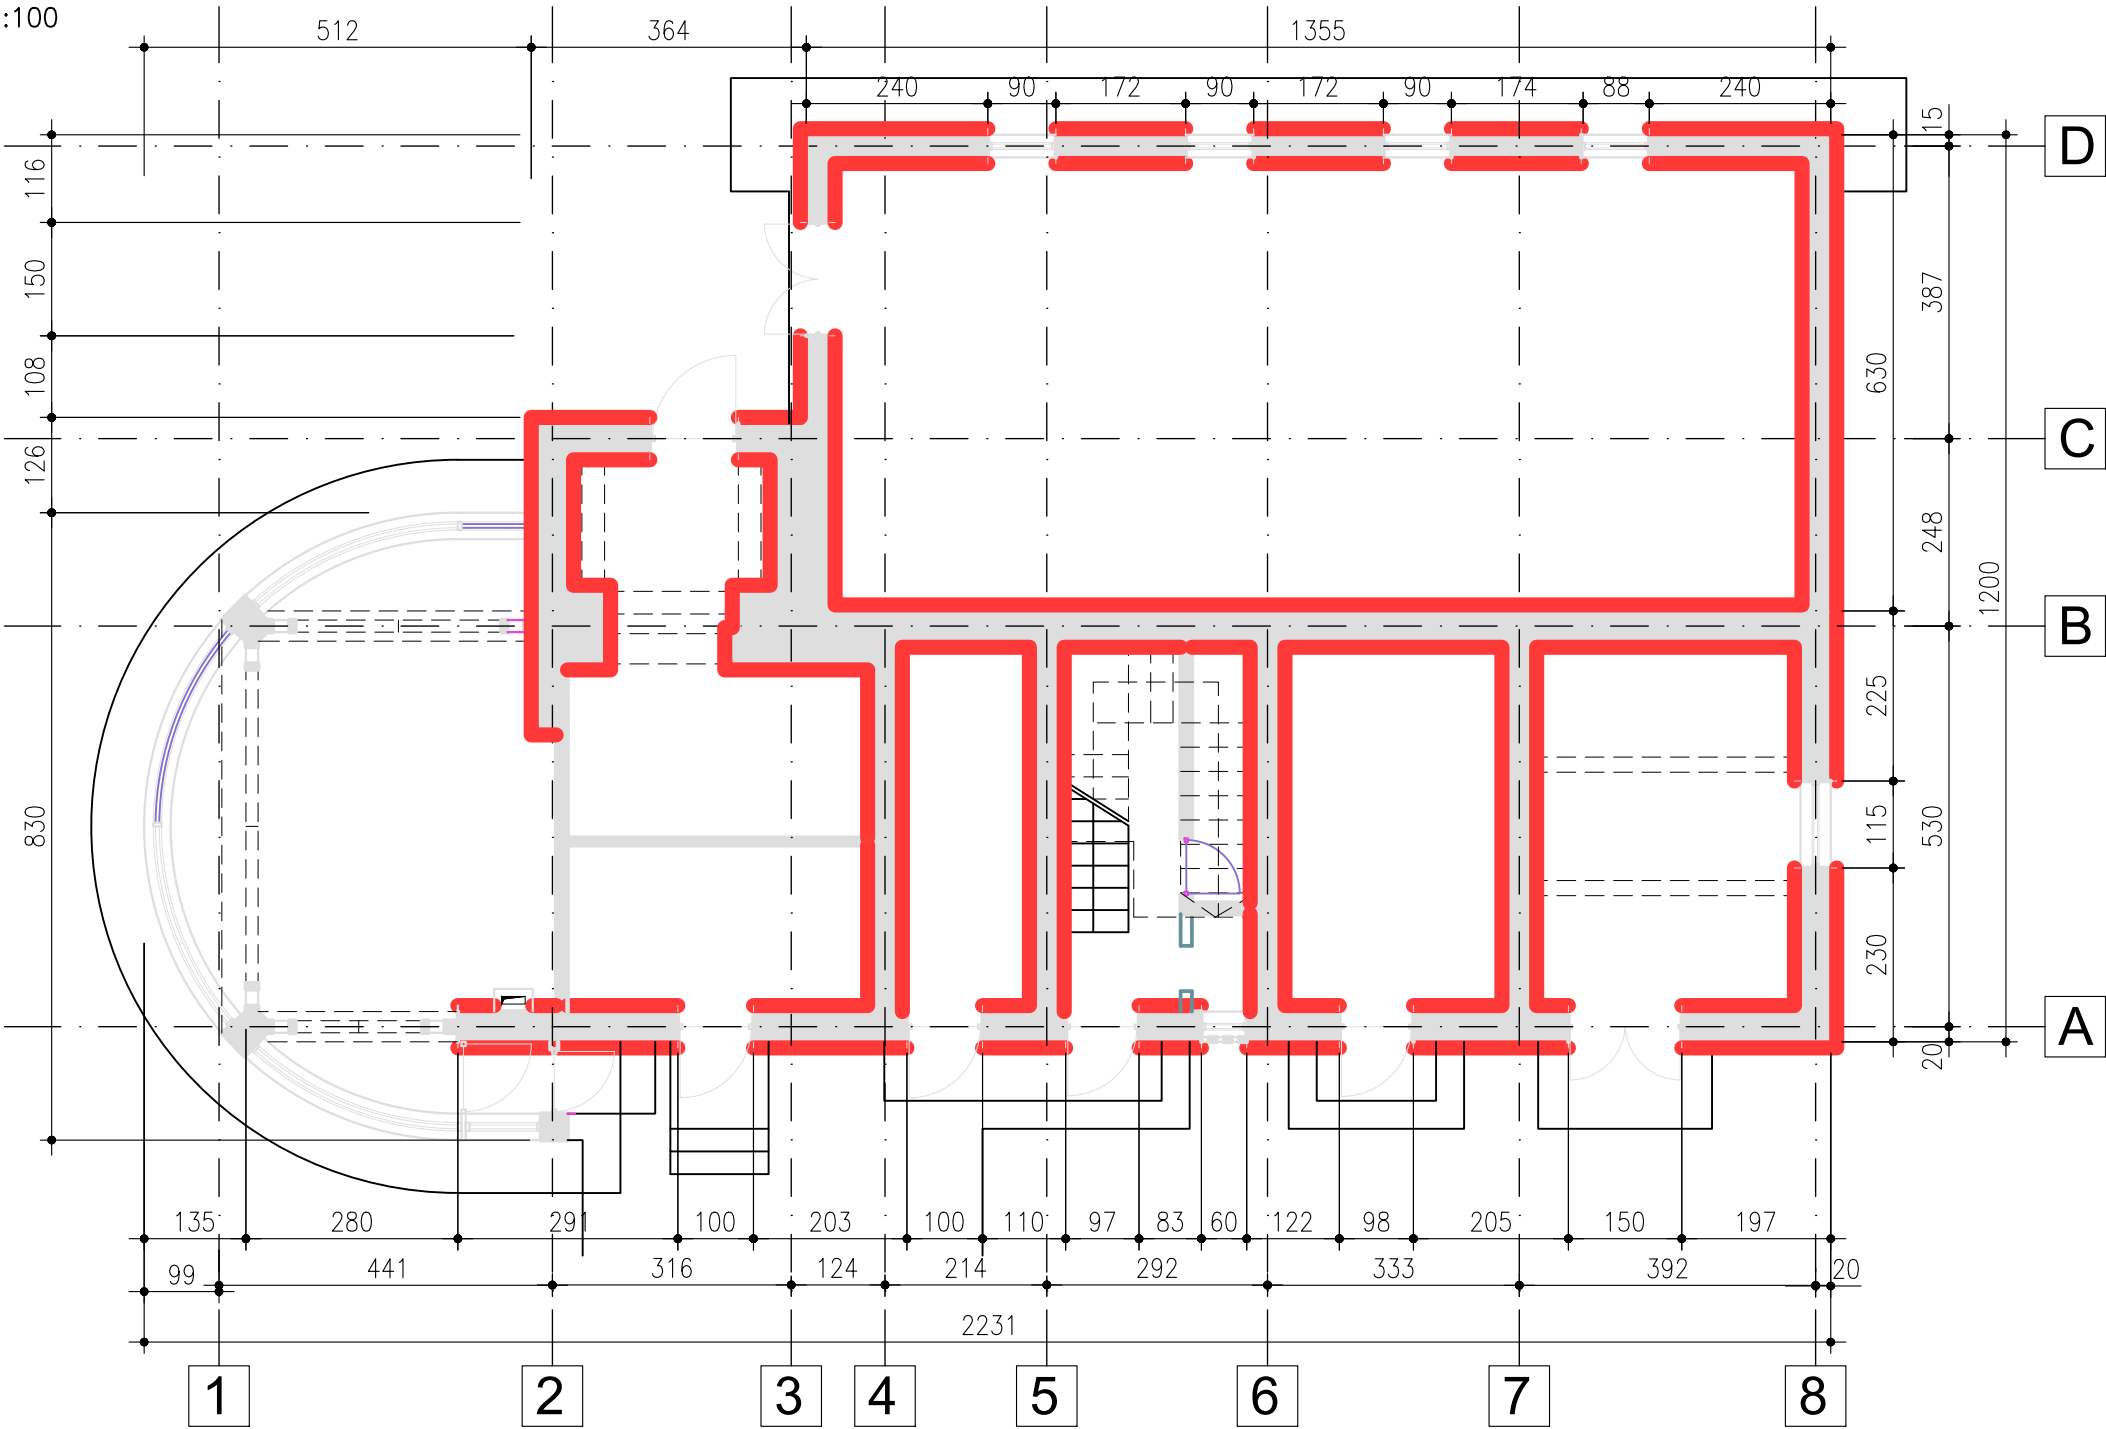
Lucrari de reparatii - Plan consolidare pereti parter / *Repair works groundfloor wall consolidation plan*

Scara/Scale 1:100

- La infrastructura:
  - Se extinde verificarea fundatiilor atat ca adancime cat si ca latime plus aspect structural. In cazul in care se constata cote de fundatie in teren umplutura sau deasupra cotei de inghet, se vor realiza subzidirii locale in ploturi. In cazul in care se constata fisuri, se vor realiza reparatii prin injectari.

- Realizare hidroizolatie exterioara la fundatii
  - Realizare sistem de tip Freeztec pentru impiedicarea urcarii apei prin capilaritate;
  - Refacere tencuieli degradate prin accesiunea apei in zidarie;

- For the infrastructure:
  - The foundation inspection will be extended to verify both depth and width, as well as structural aspects. If the foundation levels are found to be in fill soil or above the frost depth, local underpinning in sections will be carried out. If cracks or are found, repairs will be made through injection techniques.

- Installation of external waterproofing on foundations.
  - Implementation of a Freeztec system to prevent capillary rise of water.
  - Restoration of degraded plaster affected by water infiltration into the masonry.
