STATIA C.F. CHITILA / CHITILA RAILWAY STATION  
CLADIRE CALATORI / PASSENGER BUILDING

Lucrari de reparatii - Plan consolidare pereti etaj 1/  
Repair works - 1st floor wall consolidation plan

| <div><div>Denumire / Title</div><div>STATIA C.F. CHITILA.<br/>CLADIRE CALATORI. LUCRARI DE REPARATII /<br/>CHITILA RAILWAY STATION.<br/>PASSENGER BUILDING. REPAIR WORKS</div></div> | | | Scara / Scale<br>1:100 |

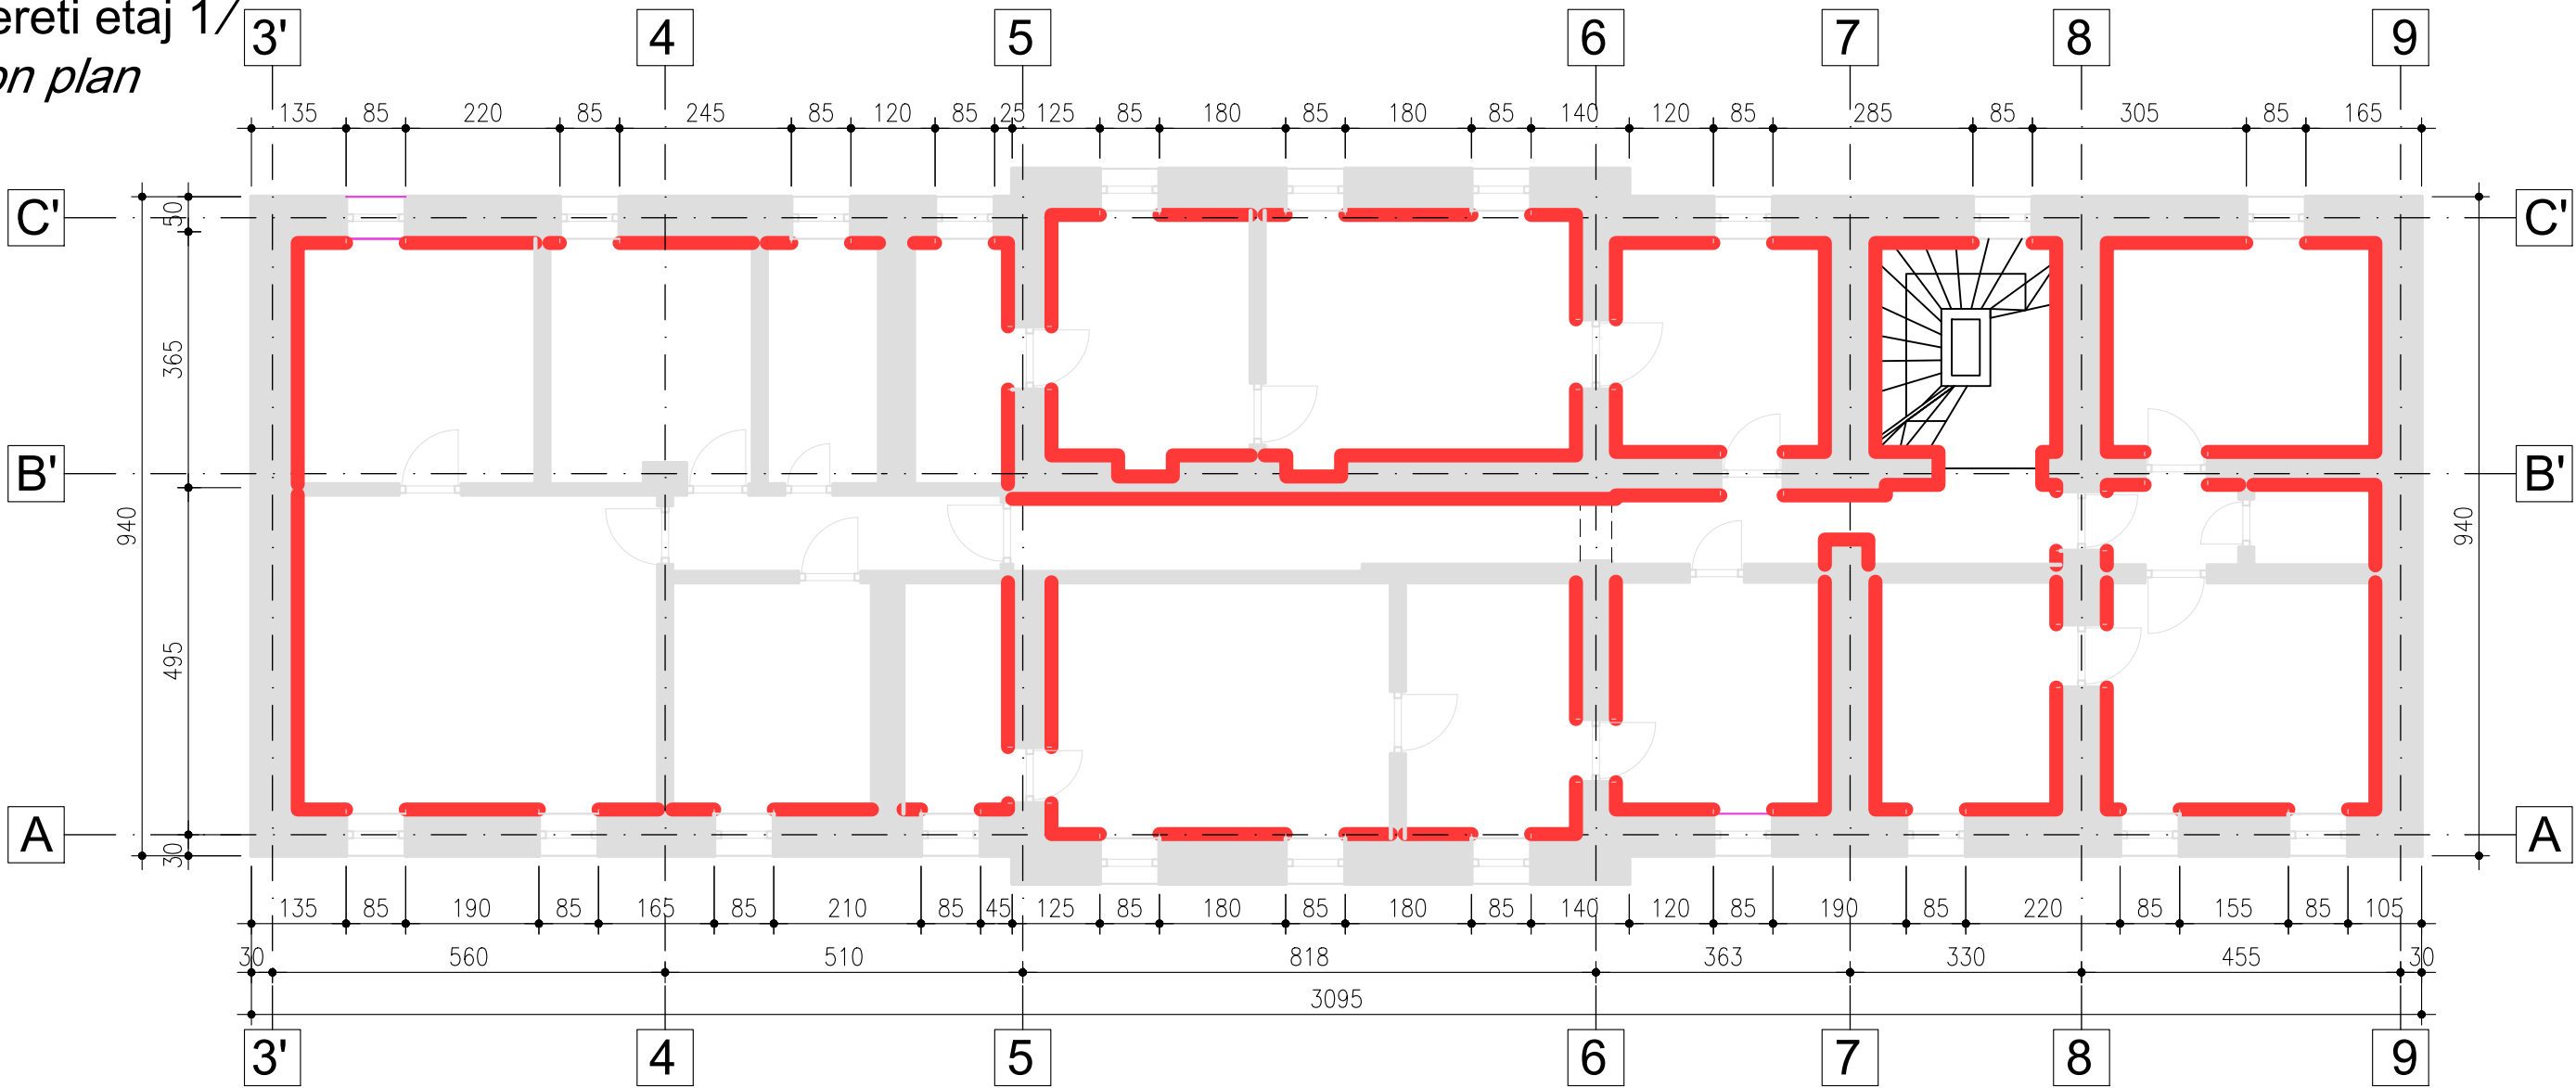
Scara/Scale 1:100

- La suprastructura :
  - Se desfac tencuielile se curata rosturile pe o adancime de 15–20mm.
  - Se vor injecta toate fisurile descoperite in zidarie/elemente beton;

- Tinand cont ca constructiile se afla in zona seismica cu  $a_g=0.30g$  si coreland acesta cu cerintele normativului P100/1–2013 in care se specifica numarul maxim de niveluri acceptate pentru constructiile de tip ZNA, tinad cont de degradarile observate in peretii de zidarie, pentru imbunatatirea conditiilor de siguranta structurala propunem consolidarea peretilor de zidarie cu camasiuala armata minim 5–6cm grosime pe ambele parti si plasa de tip STNB minim  $\varnothing 6/100 \times \varnothing 6/100$ . Avand in vedere ca constructia este reabilitata la exterior si tinand cont de starea generala a constructiei in ansamblu, lucrarile de camasiuire se vor realiza strict la interior pentru peretii exteriori si pe ambele fete pentru peretii interiori.

- For the superstructure :
  - Existing plaster will be removed, and the joints will be cleaned to a depth of 15–20 mm.
  - All cracks discovered in the masonry or concrete elements will be injected.

- Considering that the structures are located in a seismic zone with  $a_g=0.30g$  and aligning with the requirements of the P100/1–2013 code, which specifies the maximum number of floors permitted for URM–type constructions, and considering the observed degradation in masonry walls, we propose reinforcing the masonry walls with reinforced jacketing, with a minimum thickness of 5–6 cm on both sides and STNB mesh of at least  $\varnothing 6/100 \times \varnothing 6/100$ . Since the building has been rehabilitated externally and given the overall structural condition, the jacketing work will be limited to the interior side of the exterior walls and both sides of the interior walls.

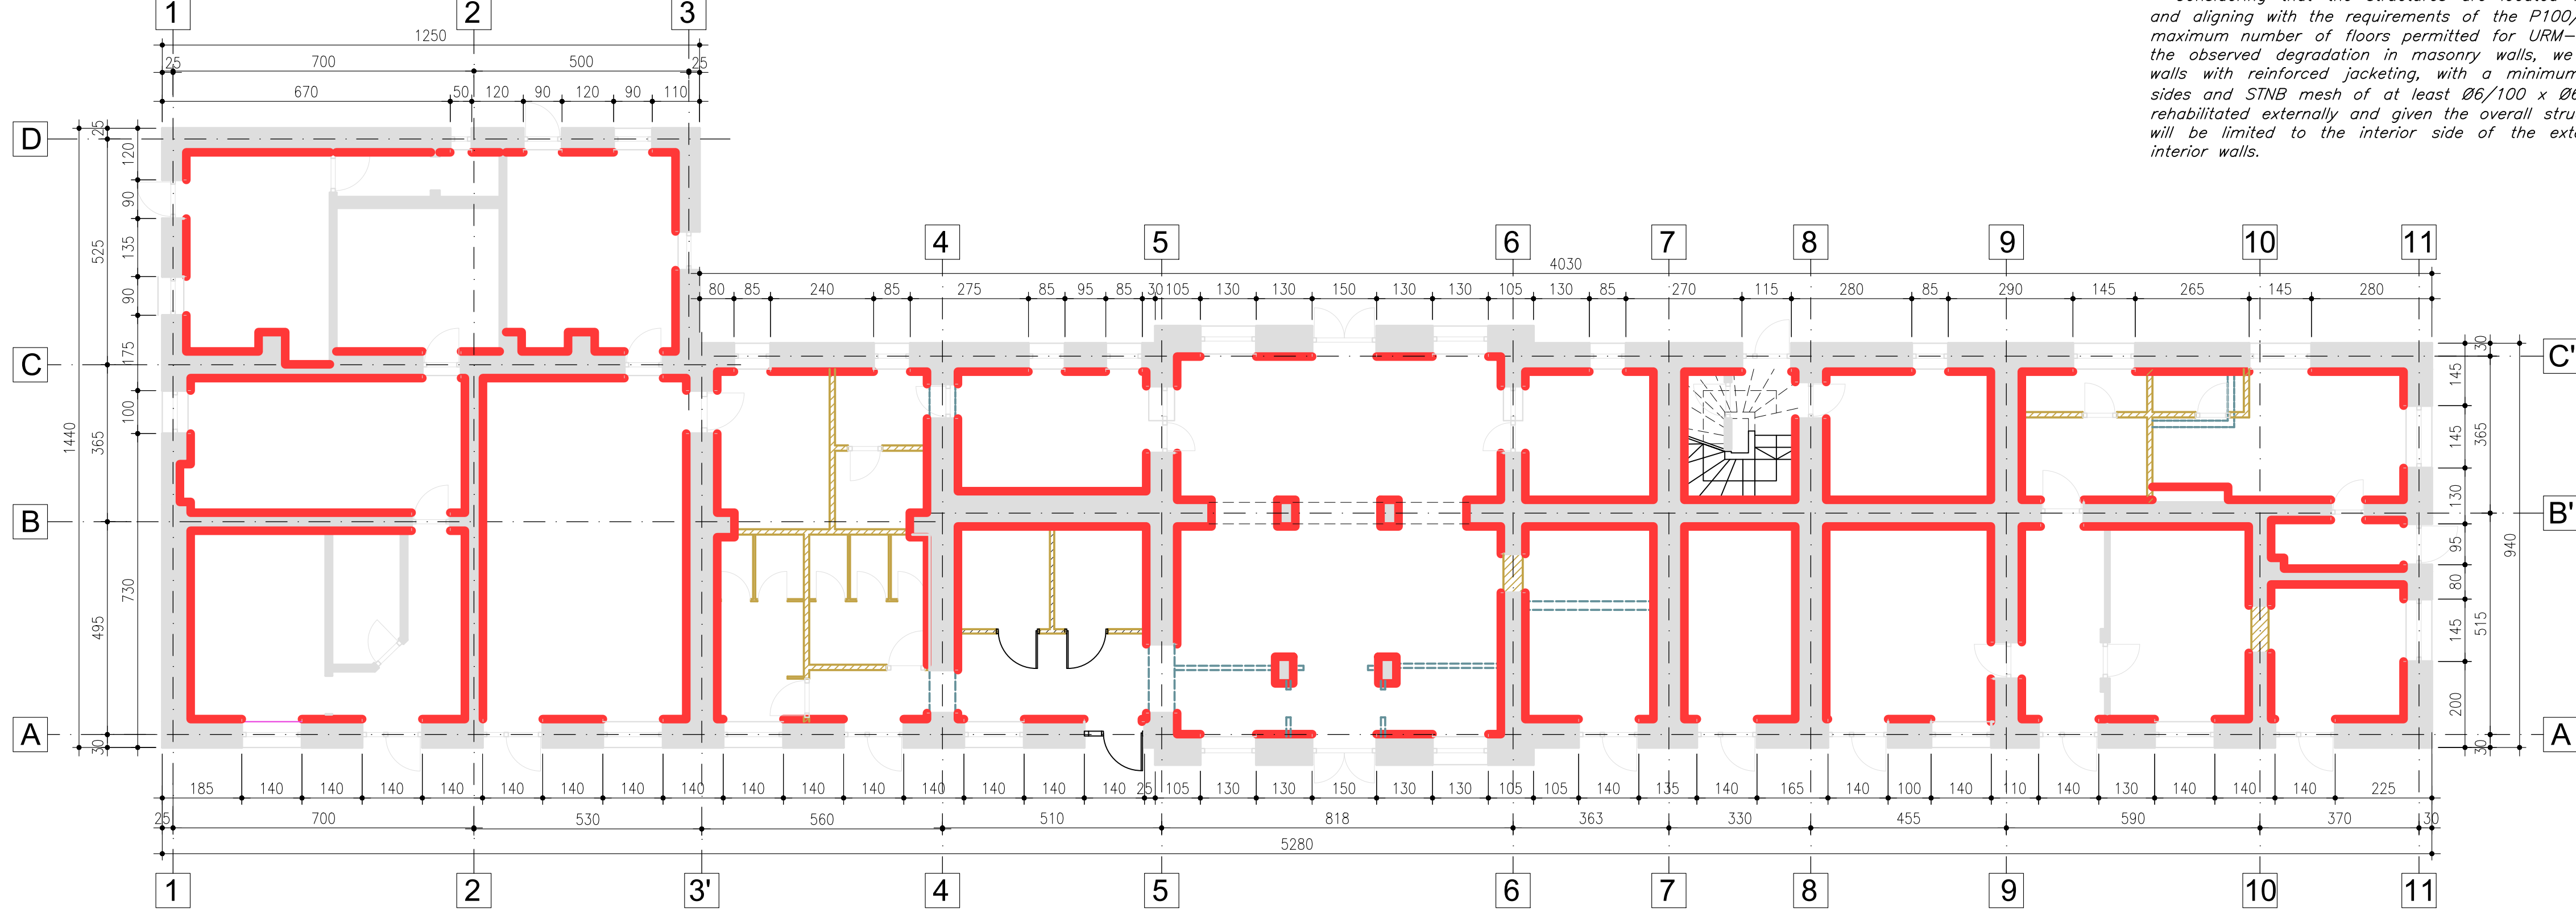
Lucrari de reparatii - Plan consolidare pereti parter / Repair works - ground floor wall consolidation plan

Scara/Scale 1:100
