Lucrari de reparatii - Plan pereti etaj 1 / Repair works - 1st floor wall plan

H.M. PAJURA.  
CLADIRE CED. LUCRARI DE REPARATII /  
PAJURA H.M.  
CED BUILDING. REPAIR WORKS

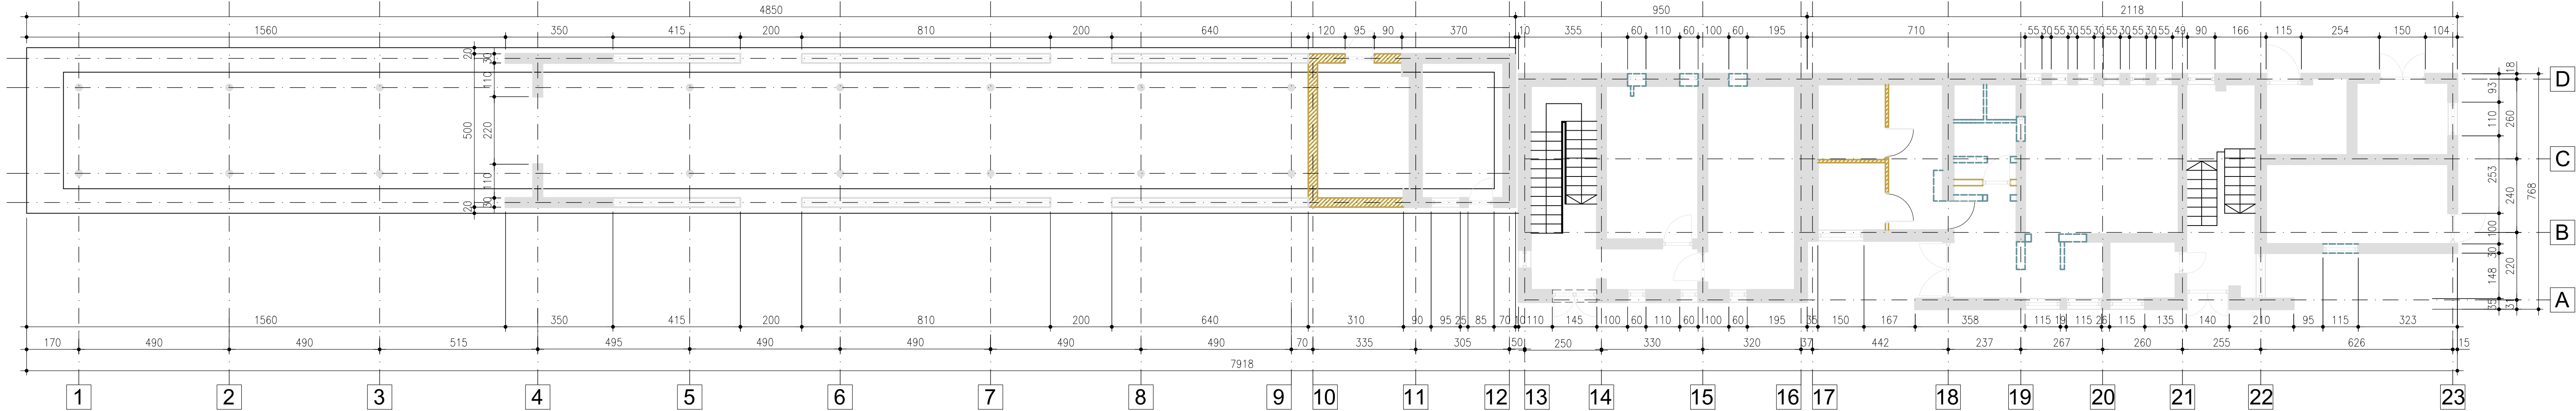
Lucrari de reparatii - Plan pereti parter / Repair works - ground floor wall plan

Scara/Scale 1:100

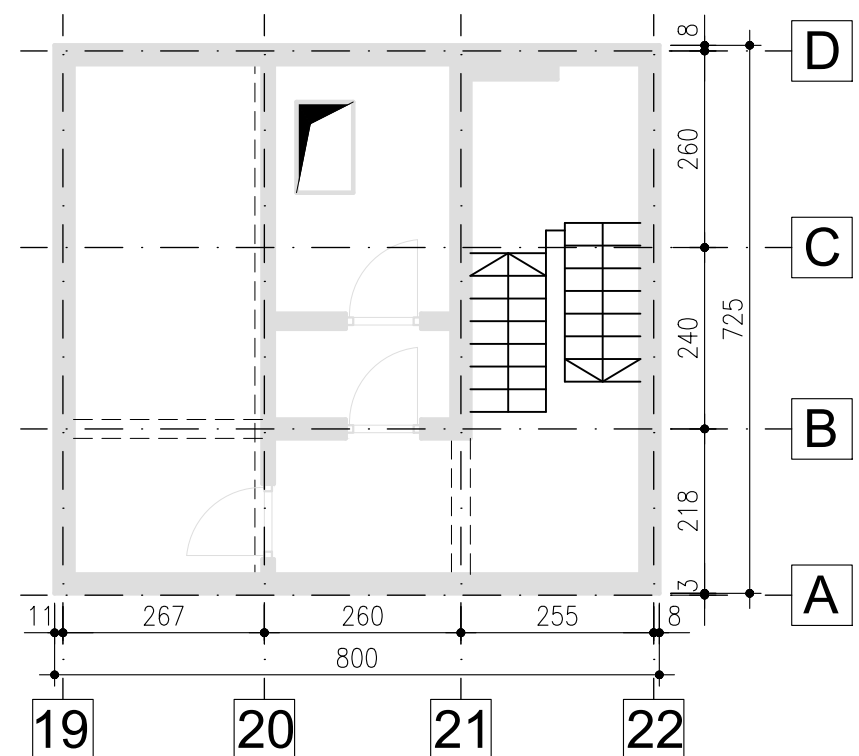
Lucrari de reparatii - Plan pereti subsol/ Repair works - basement wall plan

Scara/Scale 1:100
