STATIA C.F. PANTELIMON / *PANTELIMON RAILWAY STATION*  
CLADIRE CALATORI/ *PASSANGER BUILDING*

| STATIA C.F. PANTELIMON.<br>CLADIRE CALATORI. LUCRARI DE REPARATII /<br>PANTELIMON RAILWAY STATION.<br>PASSENGER BUILDING. REPAIR WORKS | | | |

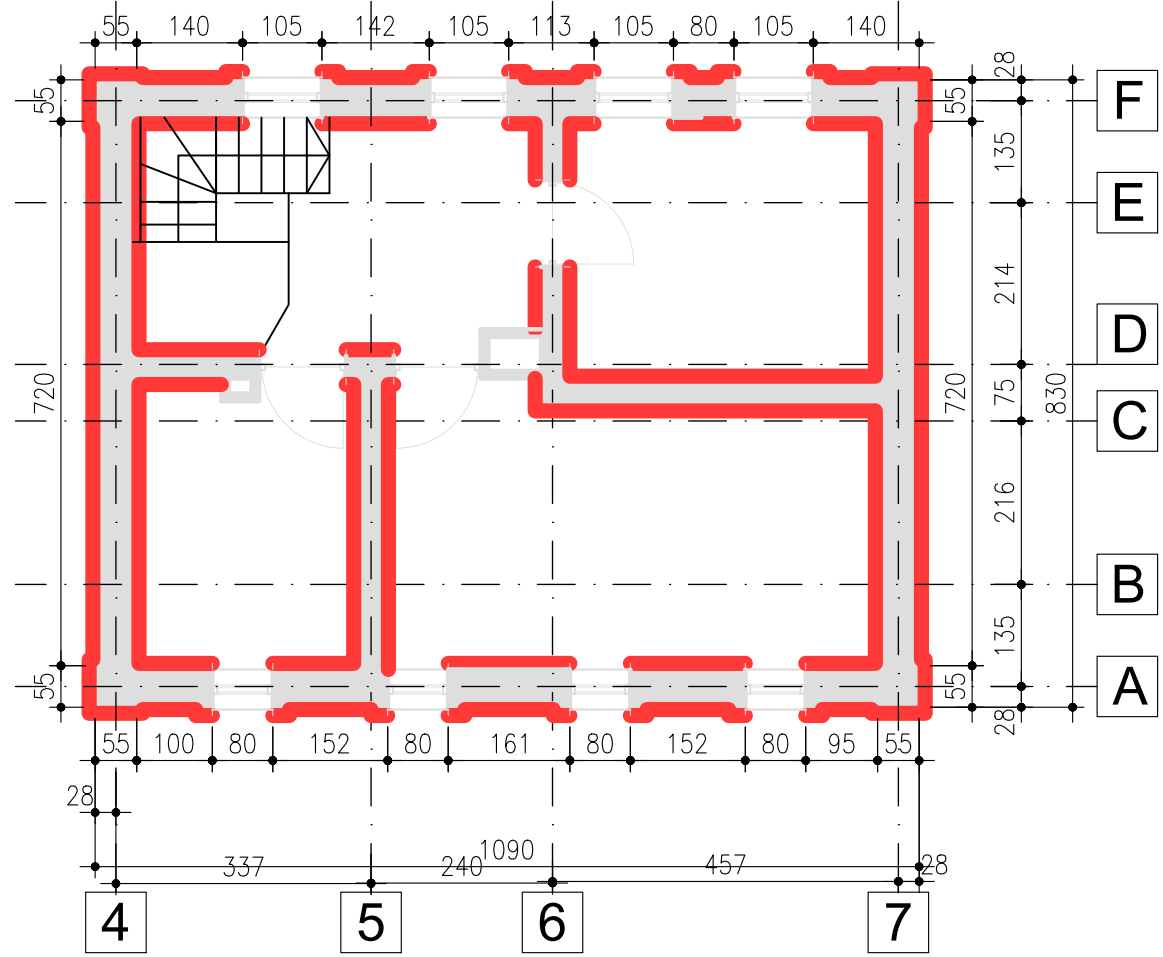
Lucrari de reparatii - Plan consolidare pereti etaj 1 / *Repair works - 1st floor wall consolidation plan*

Scara/Scale 1:100

- For the superstructure:
  - Existing plaster will be removed, and the joints will be cleaned to a depth of 15–20 mm.
  - All cracks discovered in the masonry or concrete elements will be injected.

- Considering that the structures are located in a seismic zone with  $ag=0.30g$  and aligning with the requirements of the P100/1–2013 code, which specifies the maximum number of floors permitted for URM–type constructions, and considering the observed degradation in masonry walls, we propose reinforcing the masonry walls with reinforced jacketing, with a minimum thickness of 8cm on both sides and STNB mesh of at least  $\varnothing 8/150 \times \varnothing 8/150$ .

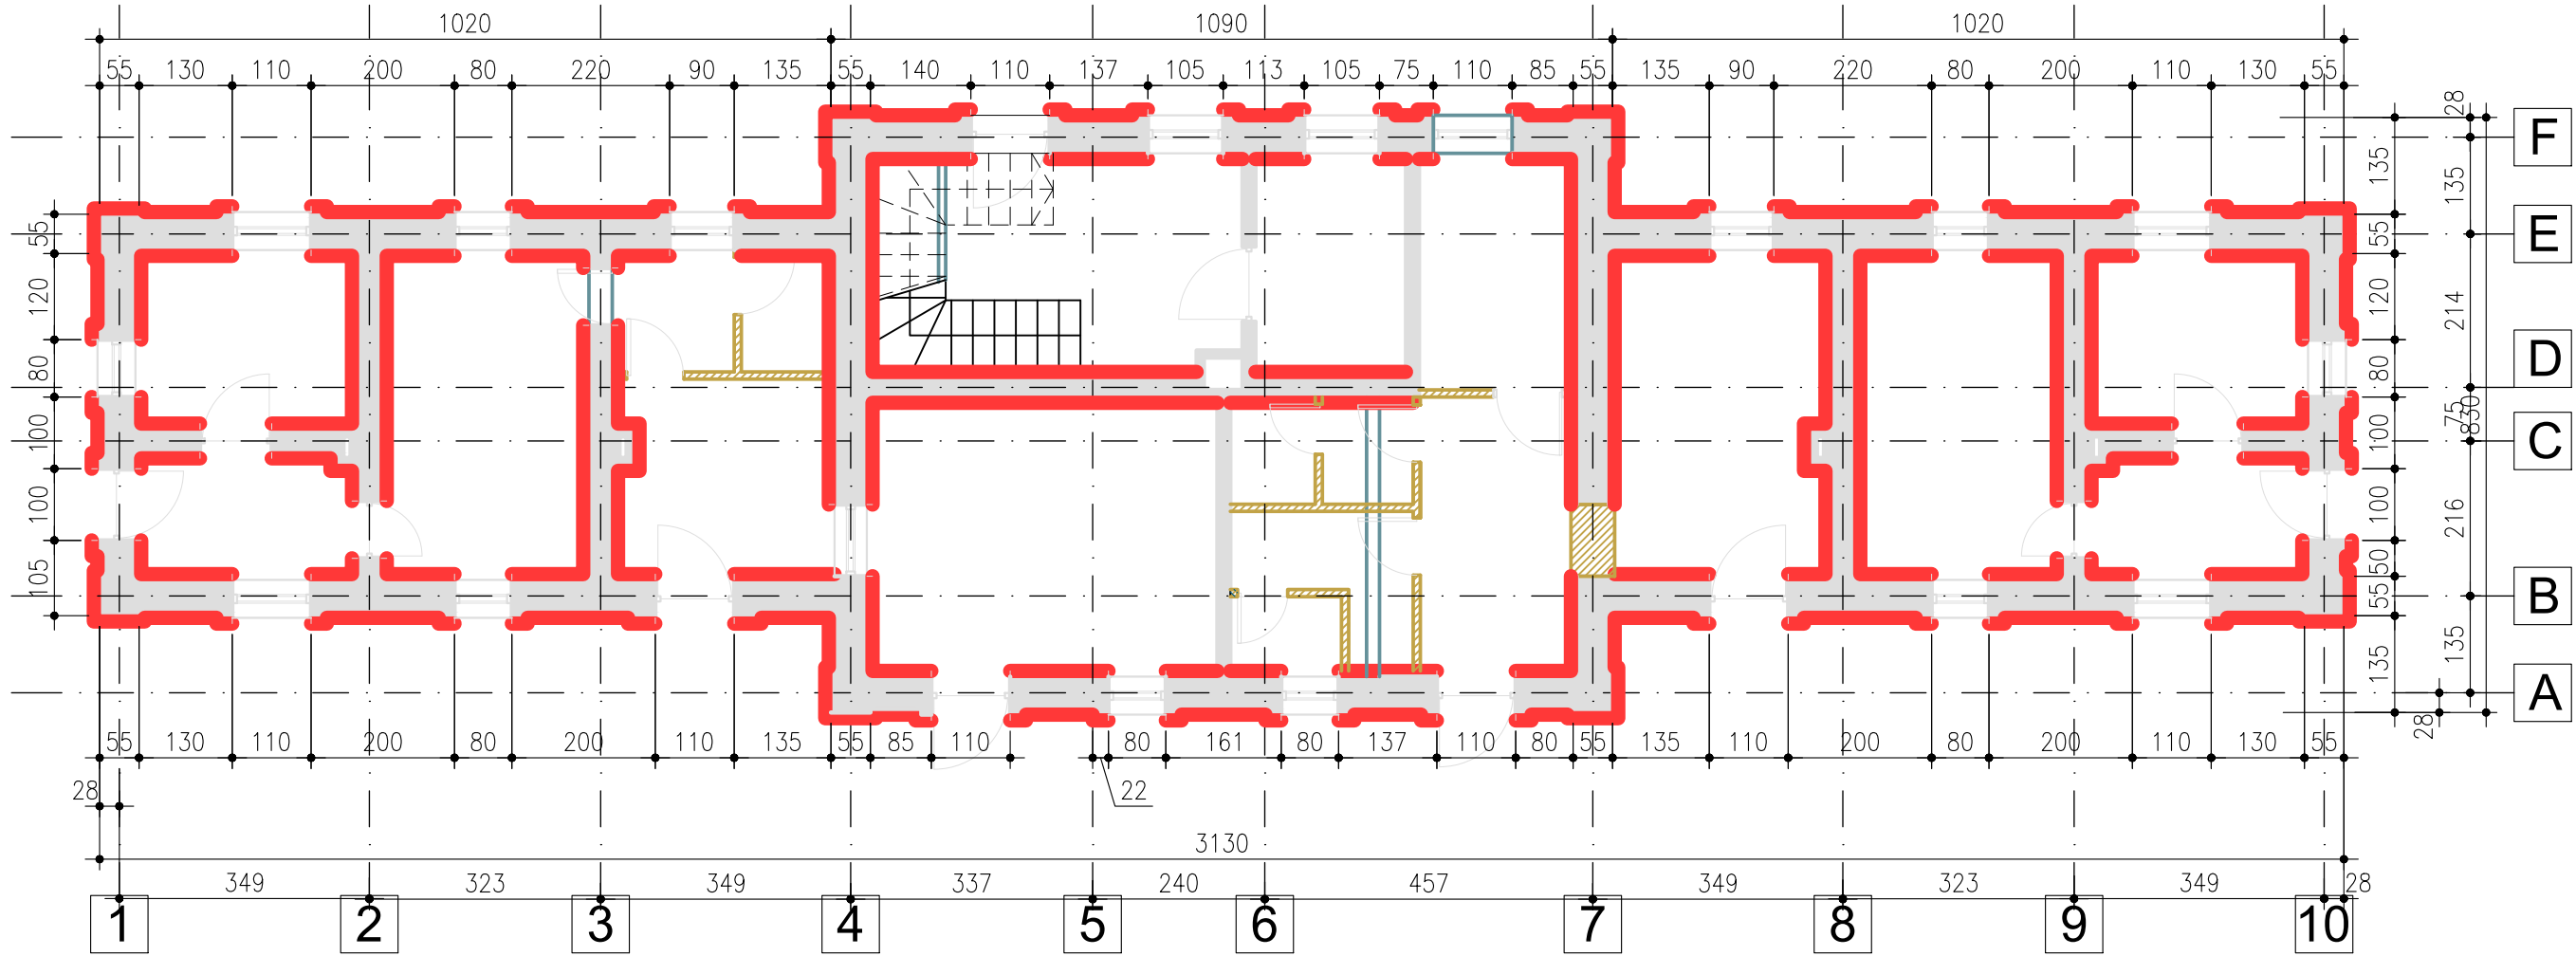
Lucrari de reparatii - Plan consolidare pereti parter / *Repair works - ground floor wall consolidation plan*

Scara/Scale 1:100

- For the infrastructure:
  - The foundation inspection will be extended to verify both depth and width, as well as structural aspects. If the foundation levels are found to be in fill soil or above the frost depth, local underpinning in sections will be carried out. If cracks or compromised concrete are found, repairs will be made through injection techniques.

- Installation of external waterproofing on foundations.
  - Implementation of a Freeztec system to prevent capillary rise of water.
  - Restoration of degraded plaster affected by water infiltration into the masonry.
