SUBSTATIE DE TRACIUNE PASAREA / PASAREA TRACTION SUBSTATION

CLADIRE BLOC COMANDA / BCC BUILDING

Lucrari de reparatii - Plan consolidare pereti parter /

Repair works - ground floor wall consolidation plan

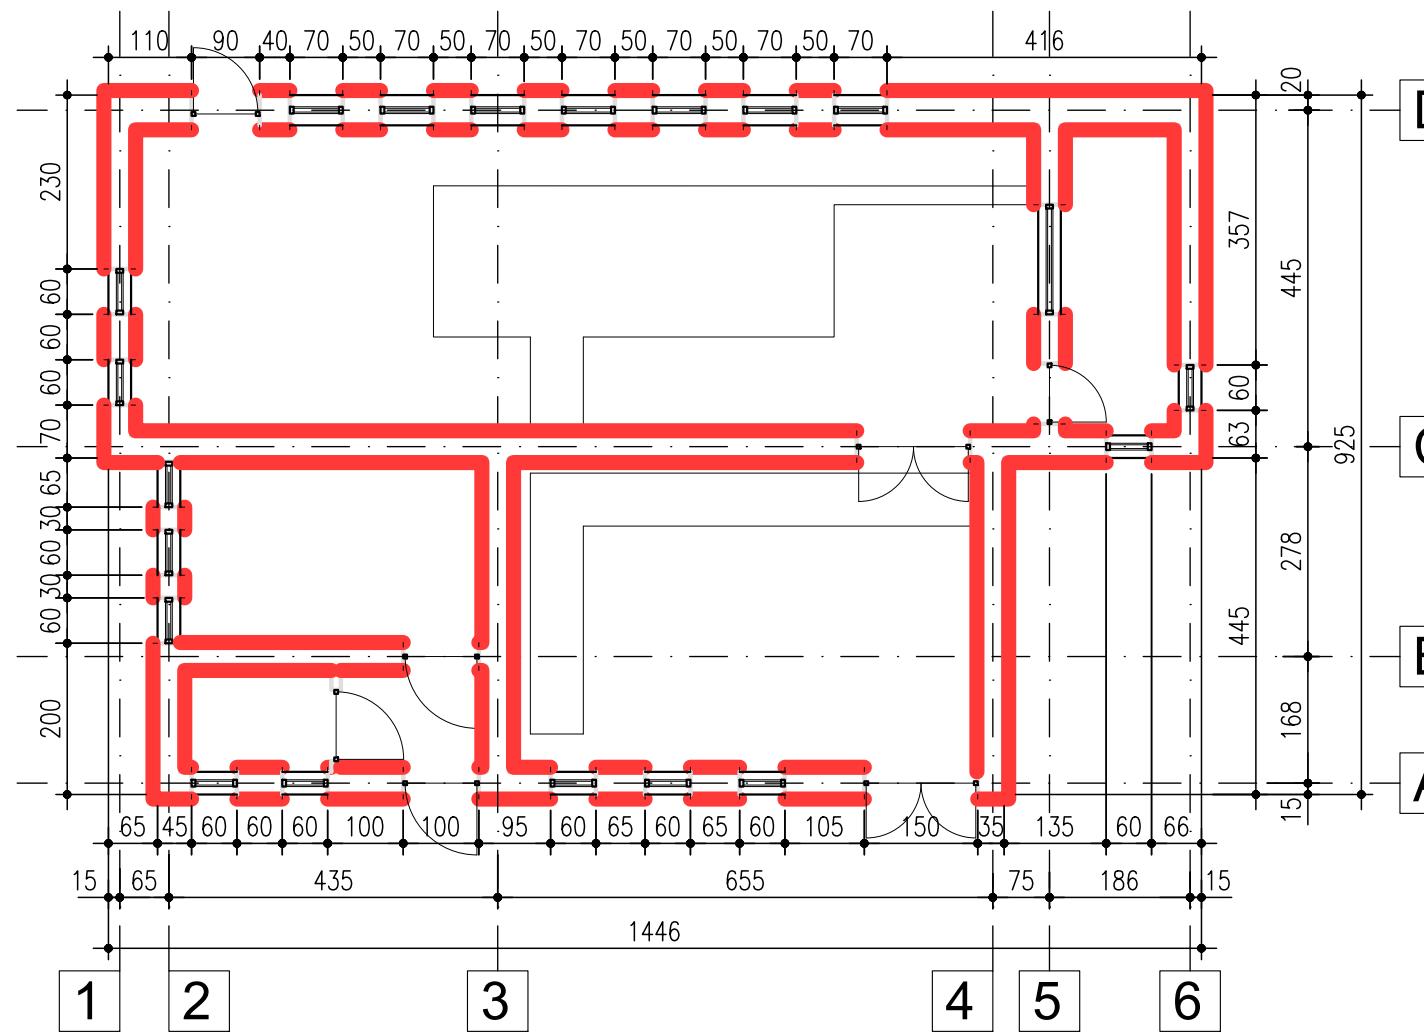
TEHNOLOGIE DE REALIZARE

- La infrastructura:
 - Se extinde verificarea fundatiilor atat ca adancime cat si ca latime plus aspect structural. In cazul in care se constata cote de fundatie in teren umplutura sau deasupra cotei de inghet, se vor realiza subzidiri locale in ploturi. In cazul in care se constata fisuri, beton colmatat se vor realiza reparatii prin injectari.

- Realizare hidroizolatie exterioara la fundatii
 - Realizare sistem de tip Freeztec pentru impiedicarea urcarii apei prin capilaritate;
 - Refacere tencuieli degradate prin accesiunea apei in zidarie;

- La suprastructura :
 - Se vor injecta toate fisurile descoperite in zidarie/elemente beton;
 - Tinand cont ca constructiile se afla in zona seismică cu $ag=0.30g$ si coreland acesta cu cerintele normativului P100/1-2013 in care se specifica numarul maxim de niveluri acceptate pentru constructiile de tip ZNA, tinand cont de degradarile observate in peretii de zidarie, pentru imbunatatirea conditiilor de siguranta structurala propunem consolidarea peretilor de zidarie cu camasua la armata minim 5-6cm grosime pe ambele parti si plasa de tip STNB minim $\varnothing 6/100 * 6/100$.

EXECUTION TECHNOLOGY

- For the infrastructure:
 - The foundation inspection will be extended to verify both depth and width, as well as structural aspects. If the foundation levels are found to be in fill soil or above the frost depth, local underpinning in sections will be carried out. If cracks or compromised concrete are found, repairs will be made through injection techniques.

- Installation of external waterproofing on foundations.
 - Implementation of a Freeztec system to prevent capillary rise of water.
 - Restoration of degraded plaster affected by water infiltration into the masonry.

- For the superstructure :
 - All cracks discovered in the masonry or concrete elements will be injected.
 - Considering that the structures are located in a seismic zone with $ag=0.30g$ and aligning with the requirements of the P100/1-2013 code, which specifies the maximum number of floors permitted for URM-type constructions, and considering the observed degradation in masonry walls, we propose reinforcing the masonry walls with reinforced jacketing, with a minimum thickness of 5-6cm on both sides and STNB mesh of at least $\varnothing 6/100 * 6/100$.
