| Amplasament /<br>Location | Reabilitarea liniei de cale ferata<br>Roman – Iasi - Frontiera |
| Forajul/Borehole: | Pod 18 |
| Proba/Sample: | PT 7 |
| Adancimea/Depth(m): | 10,00 |

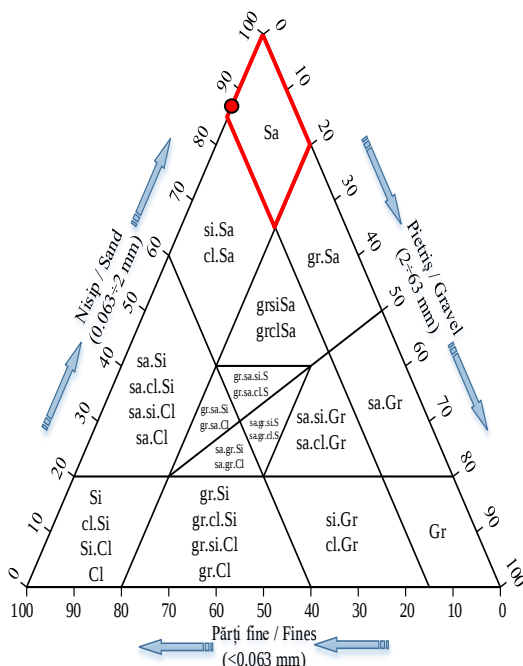
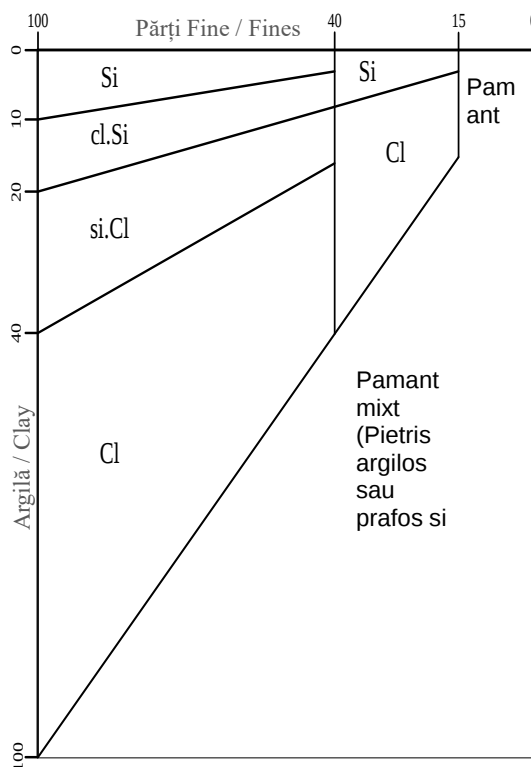
| Tip pamant / Soil group | Tip fractiune | | % | C <sub>u</sub> (Un) | C <sub>c</sub> | Forma curbei granulometrice /<br>Shape of grading curve | C <sub>u</sub> (Un) | C <sub>c</sub> |
| Pamant fin / Fine | Argila | Cl | 0 | | | | 4,96 | ##### |
| | Praf | Si | 13 | <3 | < 1 | Foarte uniforma /Very uniform | | |
| Pamant grosier / Coarse | Nisip | Sa | 87 | 3---6 | < 1 | Uniforma / Uniform | | |
