Reabilitarea liniei de cale ferată Brașov - Simeria, parte componentă a a coridorului IV Pan European, pentru circulația trenurilor cu viteză maximă de 160 km/h,
Tronsonul : Brașov - Sighișoara
 Rehabilitation of the railway line Brașov - Simeria, component Part of the IV Pan-European Corridor, for the trains circulation with maximum speed of 160 km/h,
Section : Brașov - Sighișoara

Proiect/Project 2004/RO/16/P/PA/003
 Faza / Phase: D.E. / E.D.

Denumire desen / Drawing Title :
 STATA C.F. ALBESTI-TARNAVA - CLADIRE DE CALATORI - DETALII HOL CENTRAL
 RAILWAY STATION ALBESTI-TARNAVA - TRAVELERS BUILDING - CENTRAL HALL DETAILS

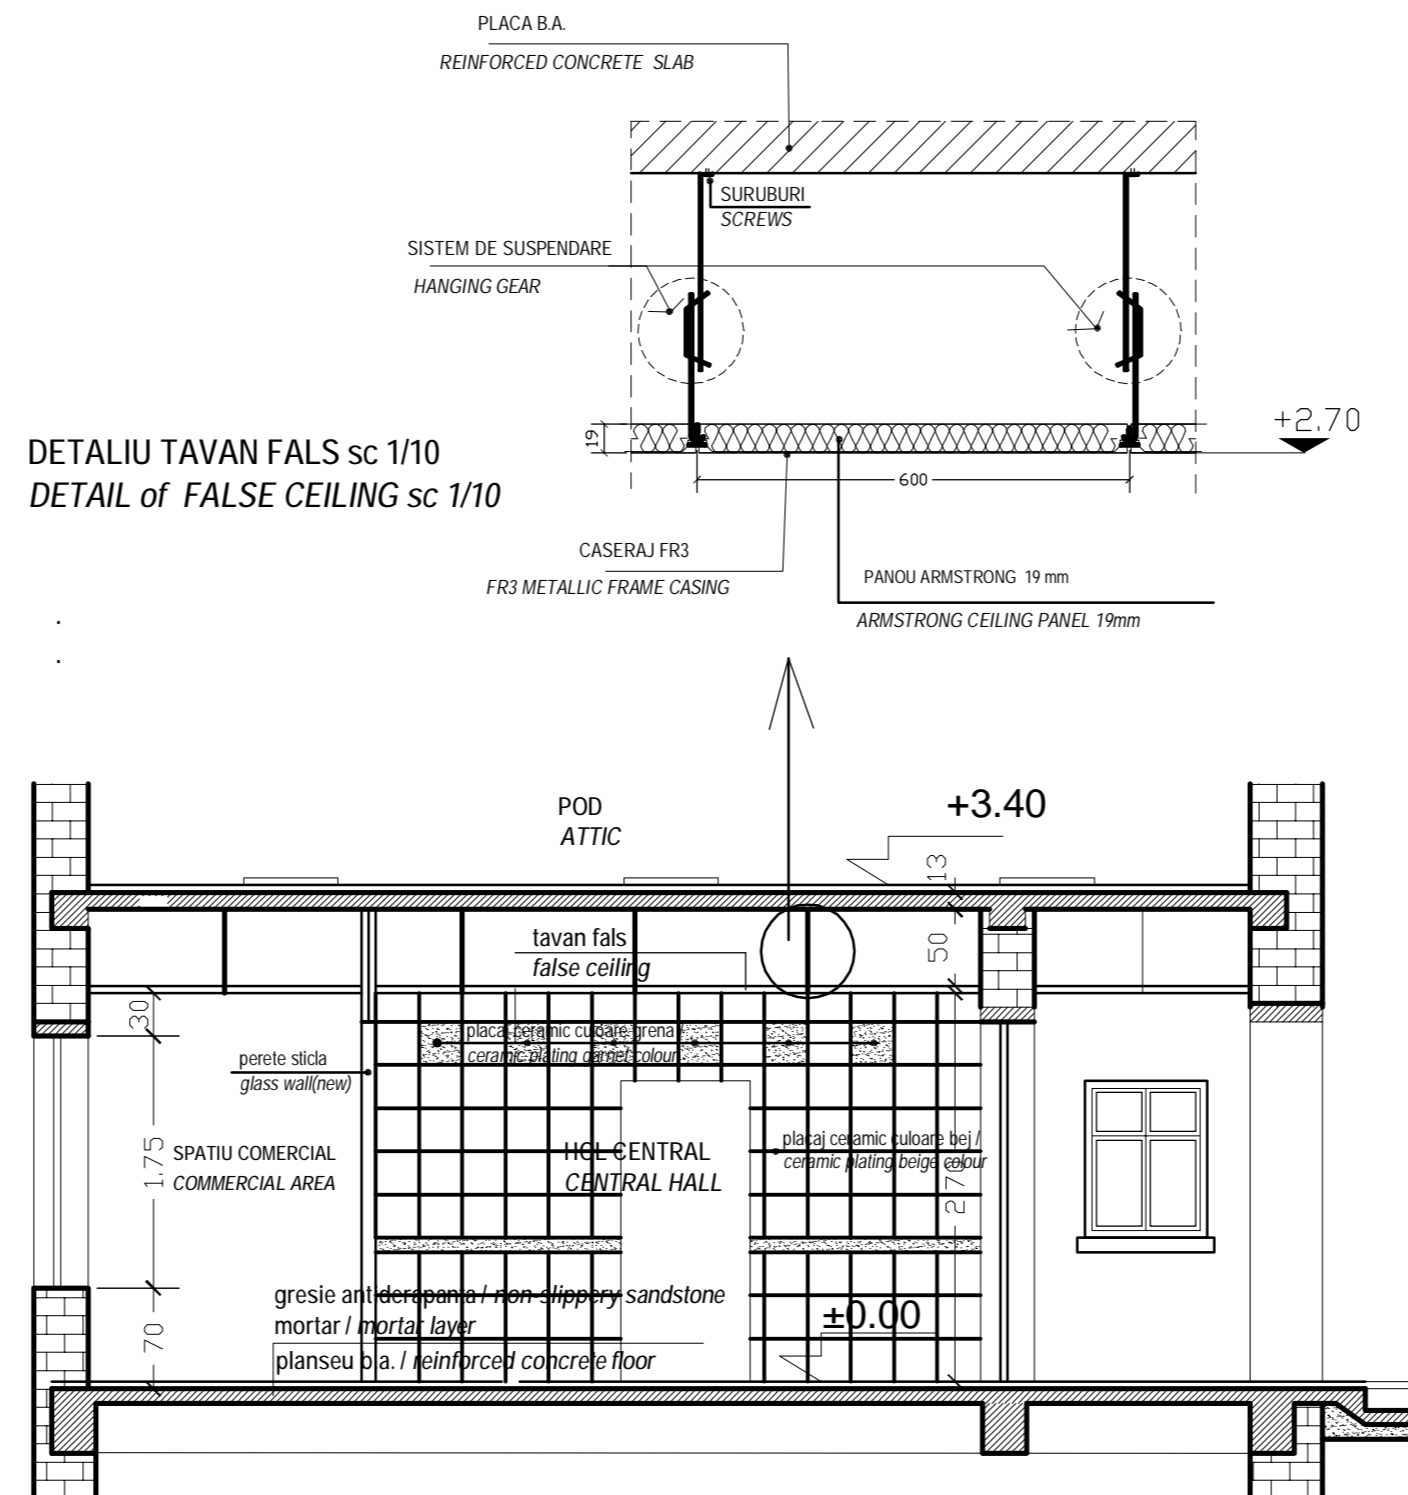
DEFASURATA HOL CENTRAL sc 1/50
CENTRAL HALL - WALL VIEW scale 1/50
(SECTION A-A)
